1 INTRODUCTION 2024

This document describes the currently noted details and brief inventory the Nobel Ten Saturation Diving System located in Takoradi, Ghana.

2 NOBEL TEN SATURATION DIVING SYSTEM

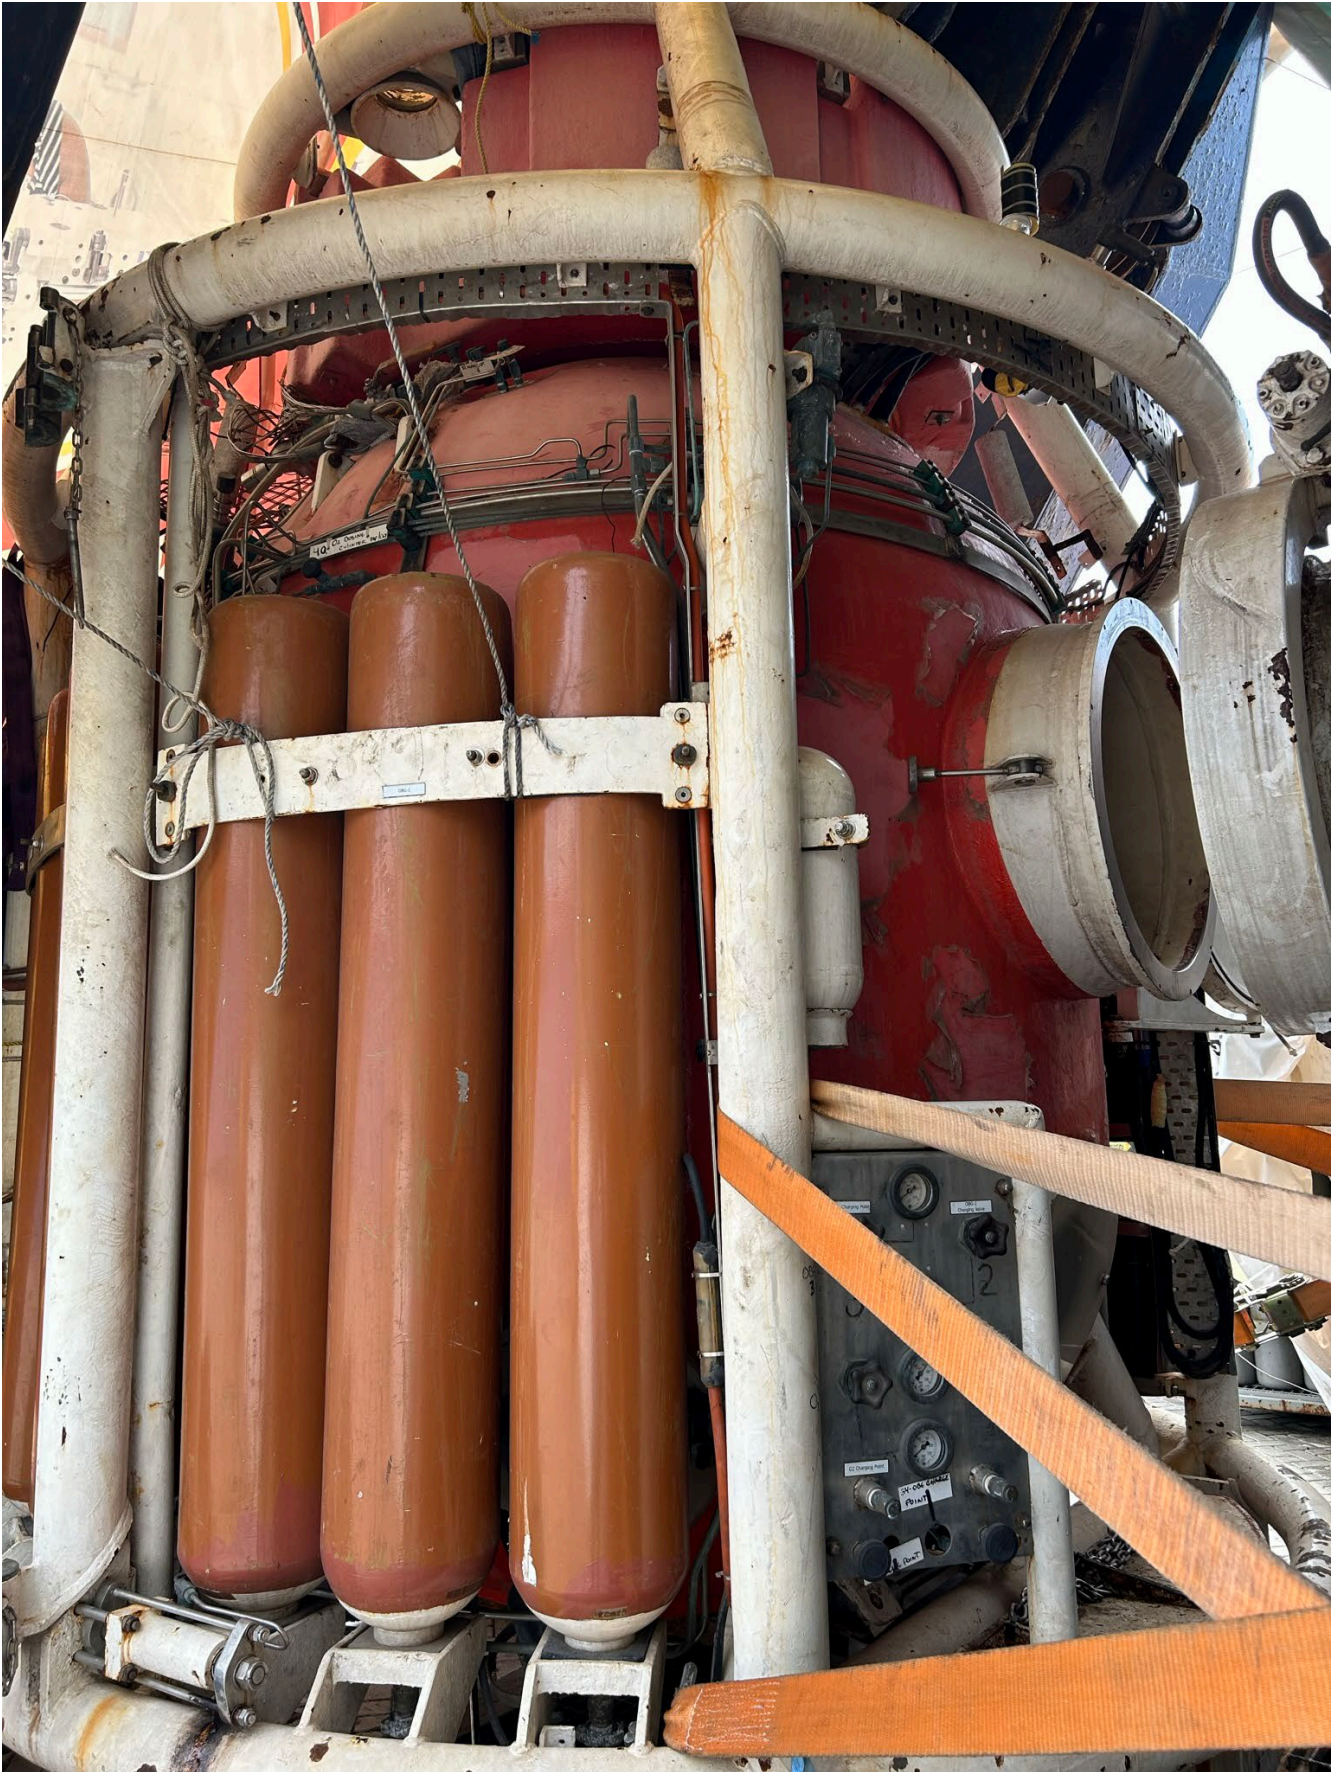
Bell to TUP Mating

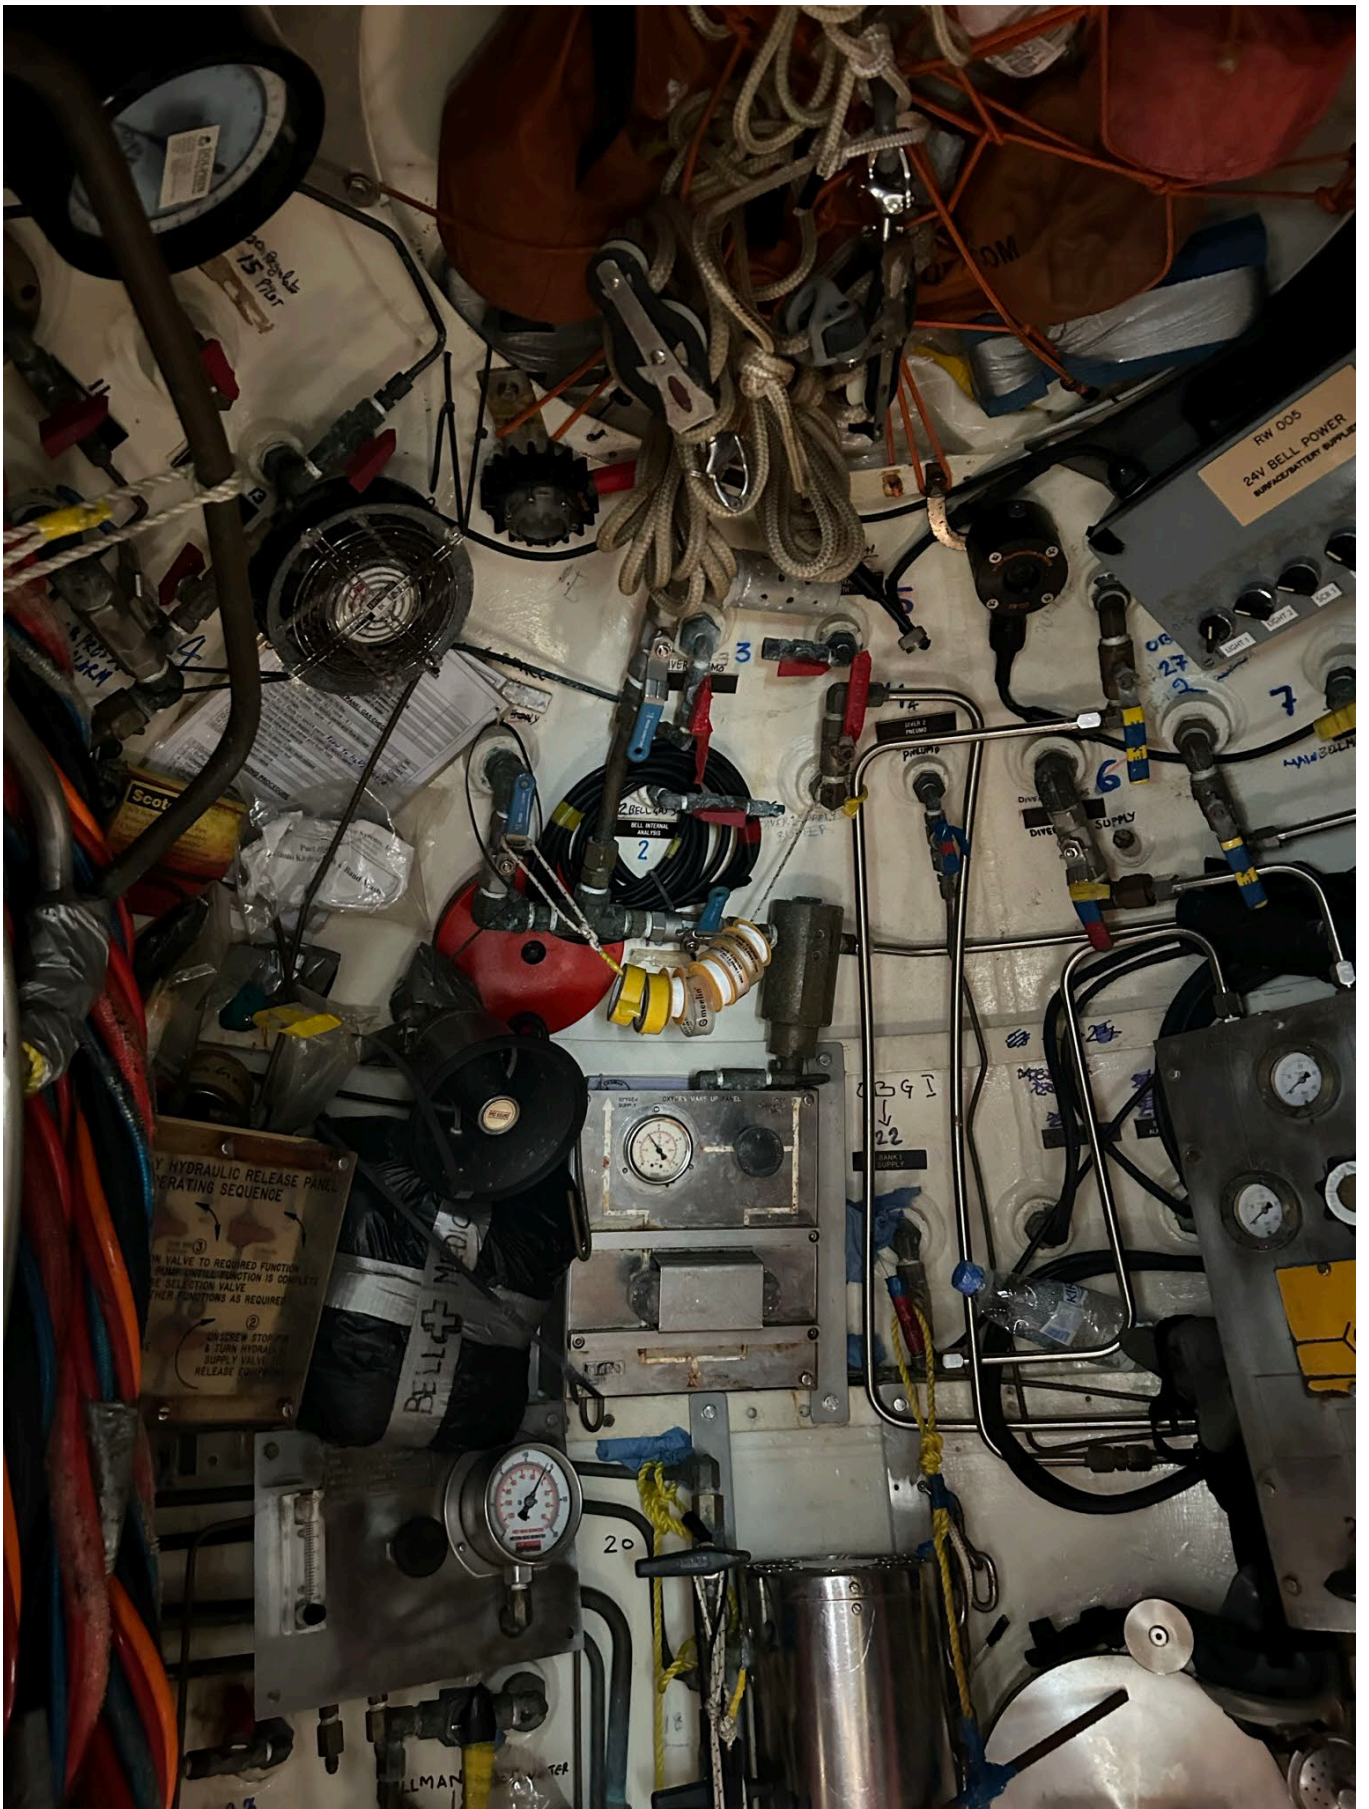
Bell General Internal Area

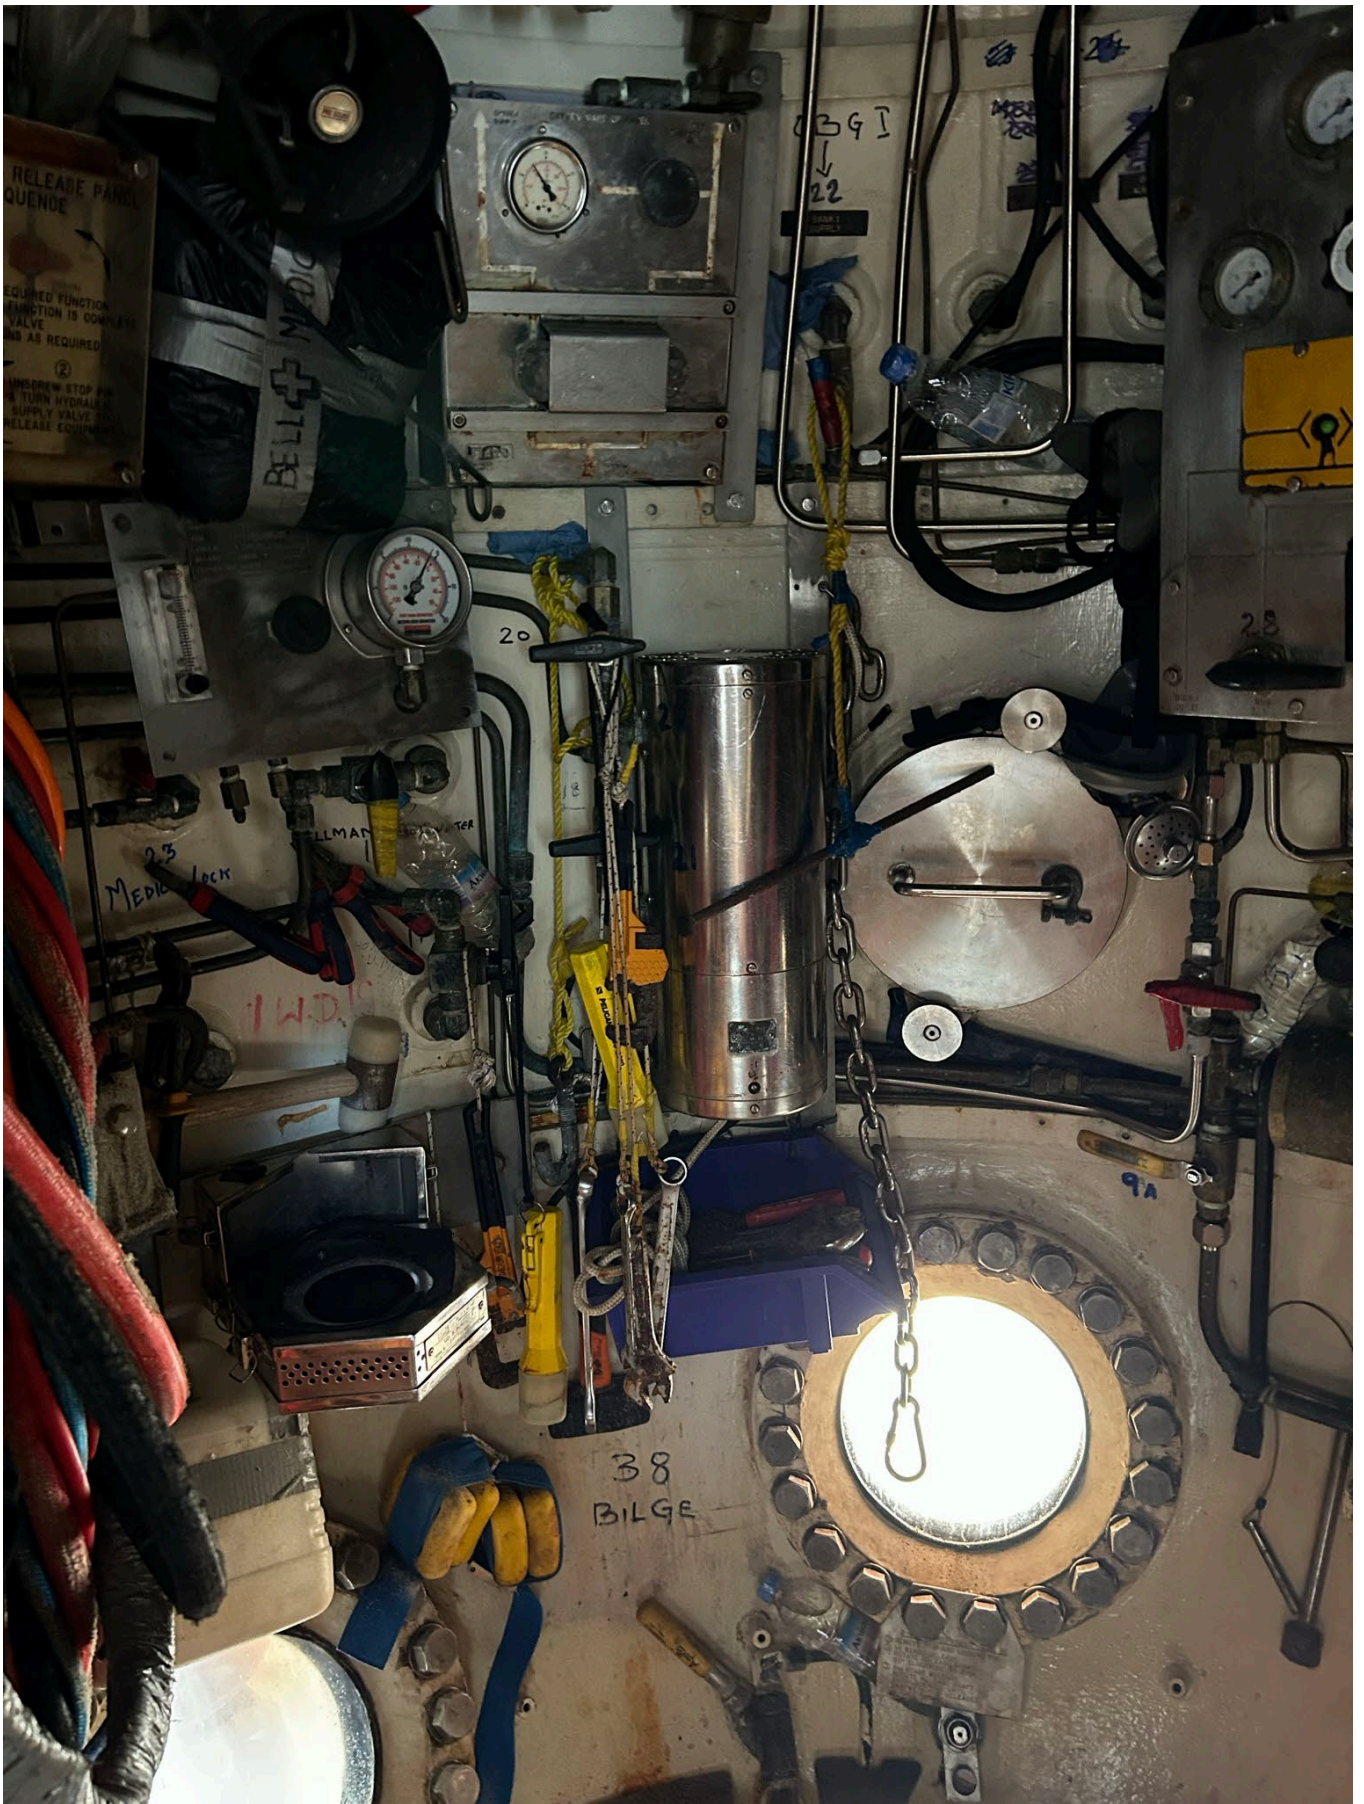
Internal Bell Viewport

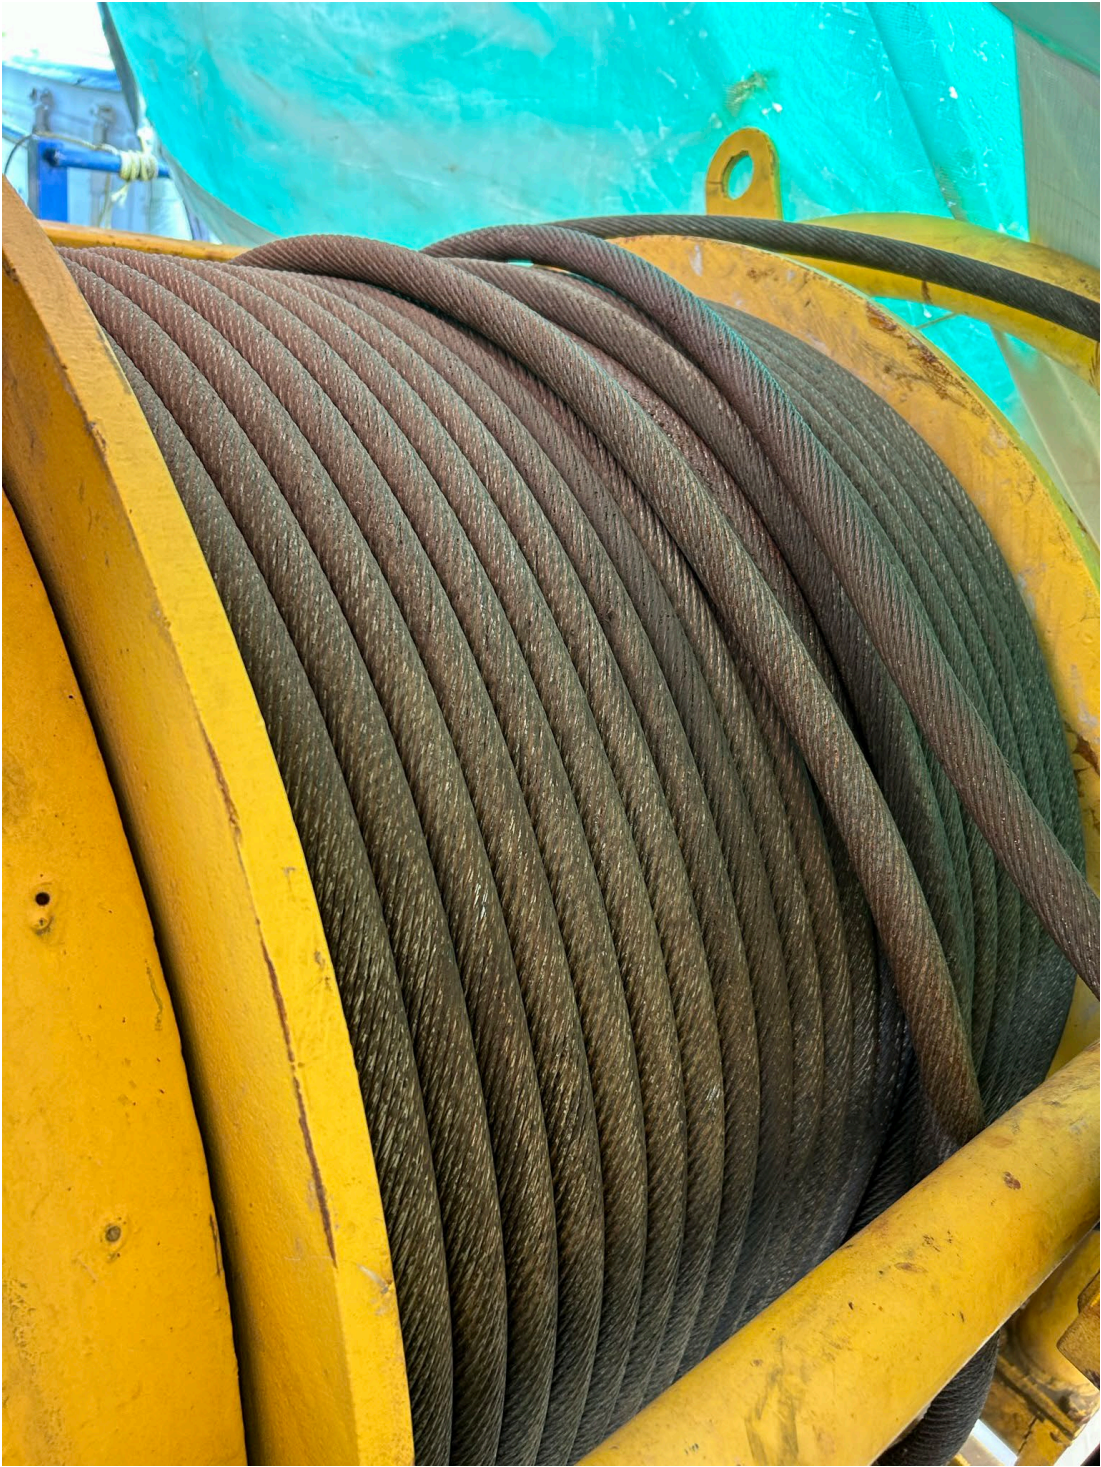
Description:	VISIBLE CONDITION:	NOTES:
Overall Exterior	OK	Needs blasting & Painting
Pulley & Sockets	OK	Needs to be blasted, painted and sockets replaced
Hydraulic Winches	Good	Needs to be function tested, some basic fittings replaced, brakes tested & Hydraulics Serviced
Wire Rope	Good	Needs wire re-certification, greased, socket fastening & function tested
Ladder	Good	Needs to be Blasted & Painted
Wire Guides	OK	Needs to be blasted & Painted
Constant Tensioner	OK	Needs to be blasted, painted and function tested
Anodes / Cathodic Protection	Good	Secured in place and only 5% depleted
Pipework & Whips (Internal & External)	TBC	Needs to be function tested
Bell Lighting & Cameras (Internal & External)	TBC	Needs to be function tested
All Electrical (Internal & External)	TBC	Needs to be function tested
Spares	OK	Will need additional spares
All Valves & Fittings (Internal & External)	Good	Needs to be function tested

Bell A Frame Winch

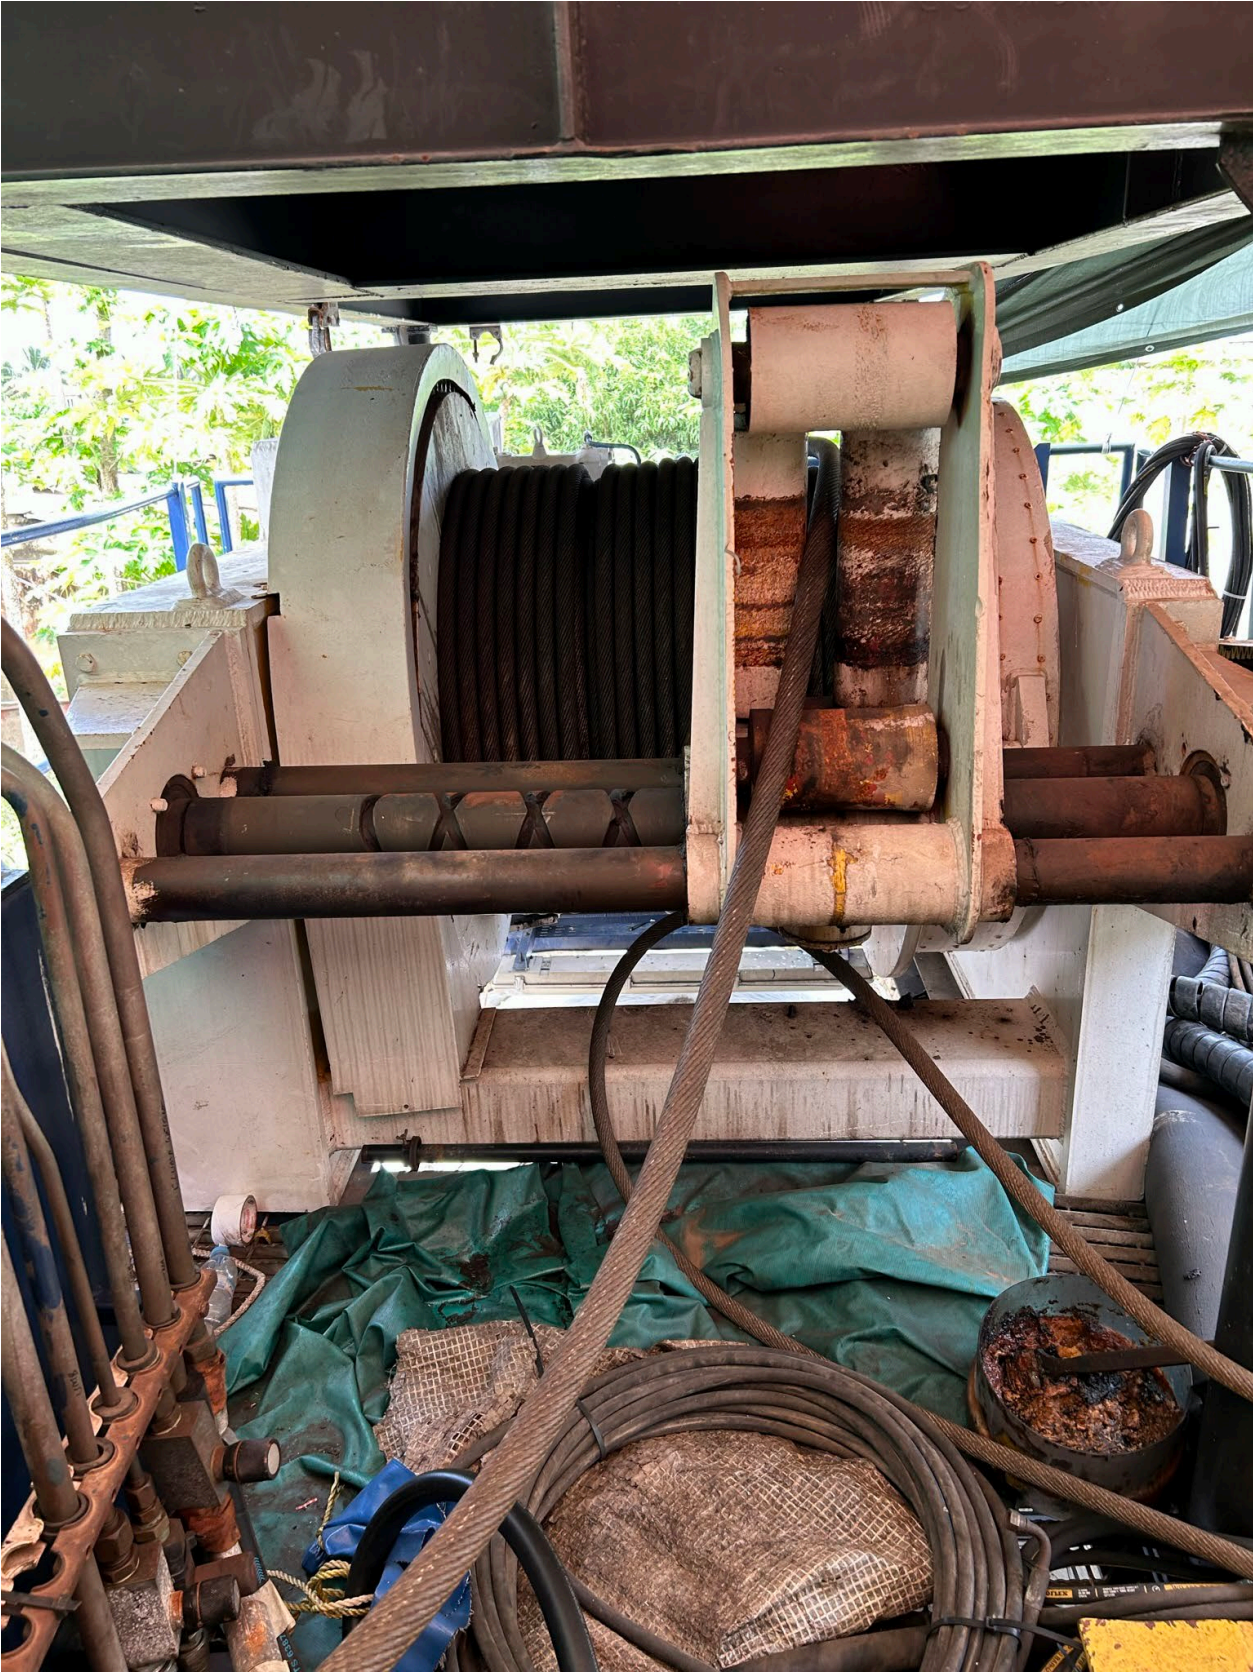
Description:	VISIBLE CONDITION:	NOTES:
Overall Exterior	OK	Needs blasting, painting, badging and labelling
Pulley & Sockets	OK	Needs to be blasted, painted and sockets replaced
Hydraulic Winches	Good	Needs to be function tested, some basic fittings replaced, brakes tested & Hydraulics Serviced
Wire Rope	Good	Needs wire re-certification, greased, socket fastening & function tested
Ladder	Good	Needs to be Blasted & Painted
Wire Guides	OK	Needs to be blasted & Painted
Pipework, hoses & Whips	TBC	Needs to be function tested
All Valves & Fittings	Good	Needs to be function tested & some fittings replaced
Padeyes	Good	Need to be load tested
Spares	OK	Will need additional spares

Trolley Winch

There will be a requirement to conduct hydraulic servicing and load testing which can be facilitated by using an crane, load cells and qualified technicians.

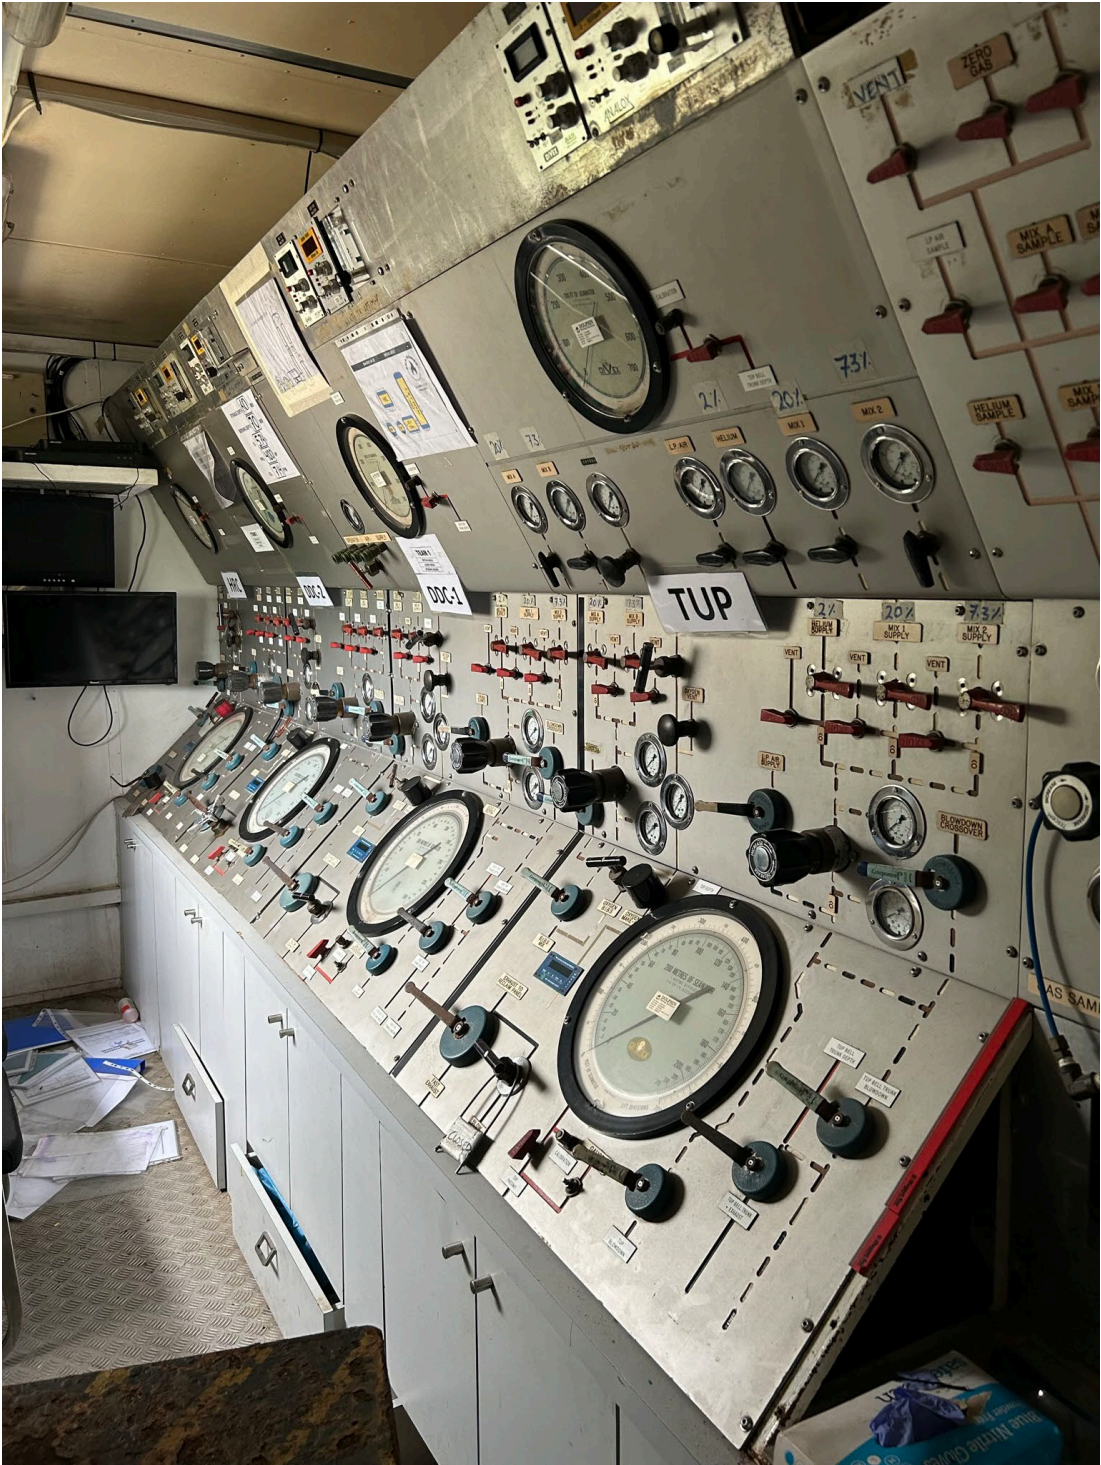
Saturation Control Panel

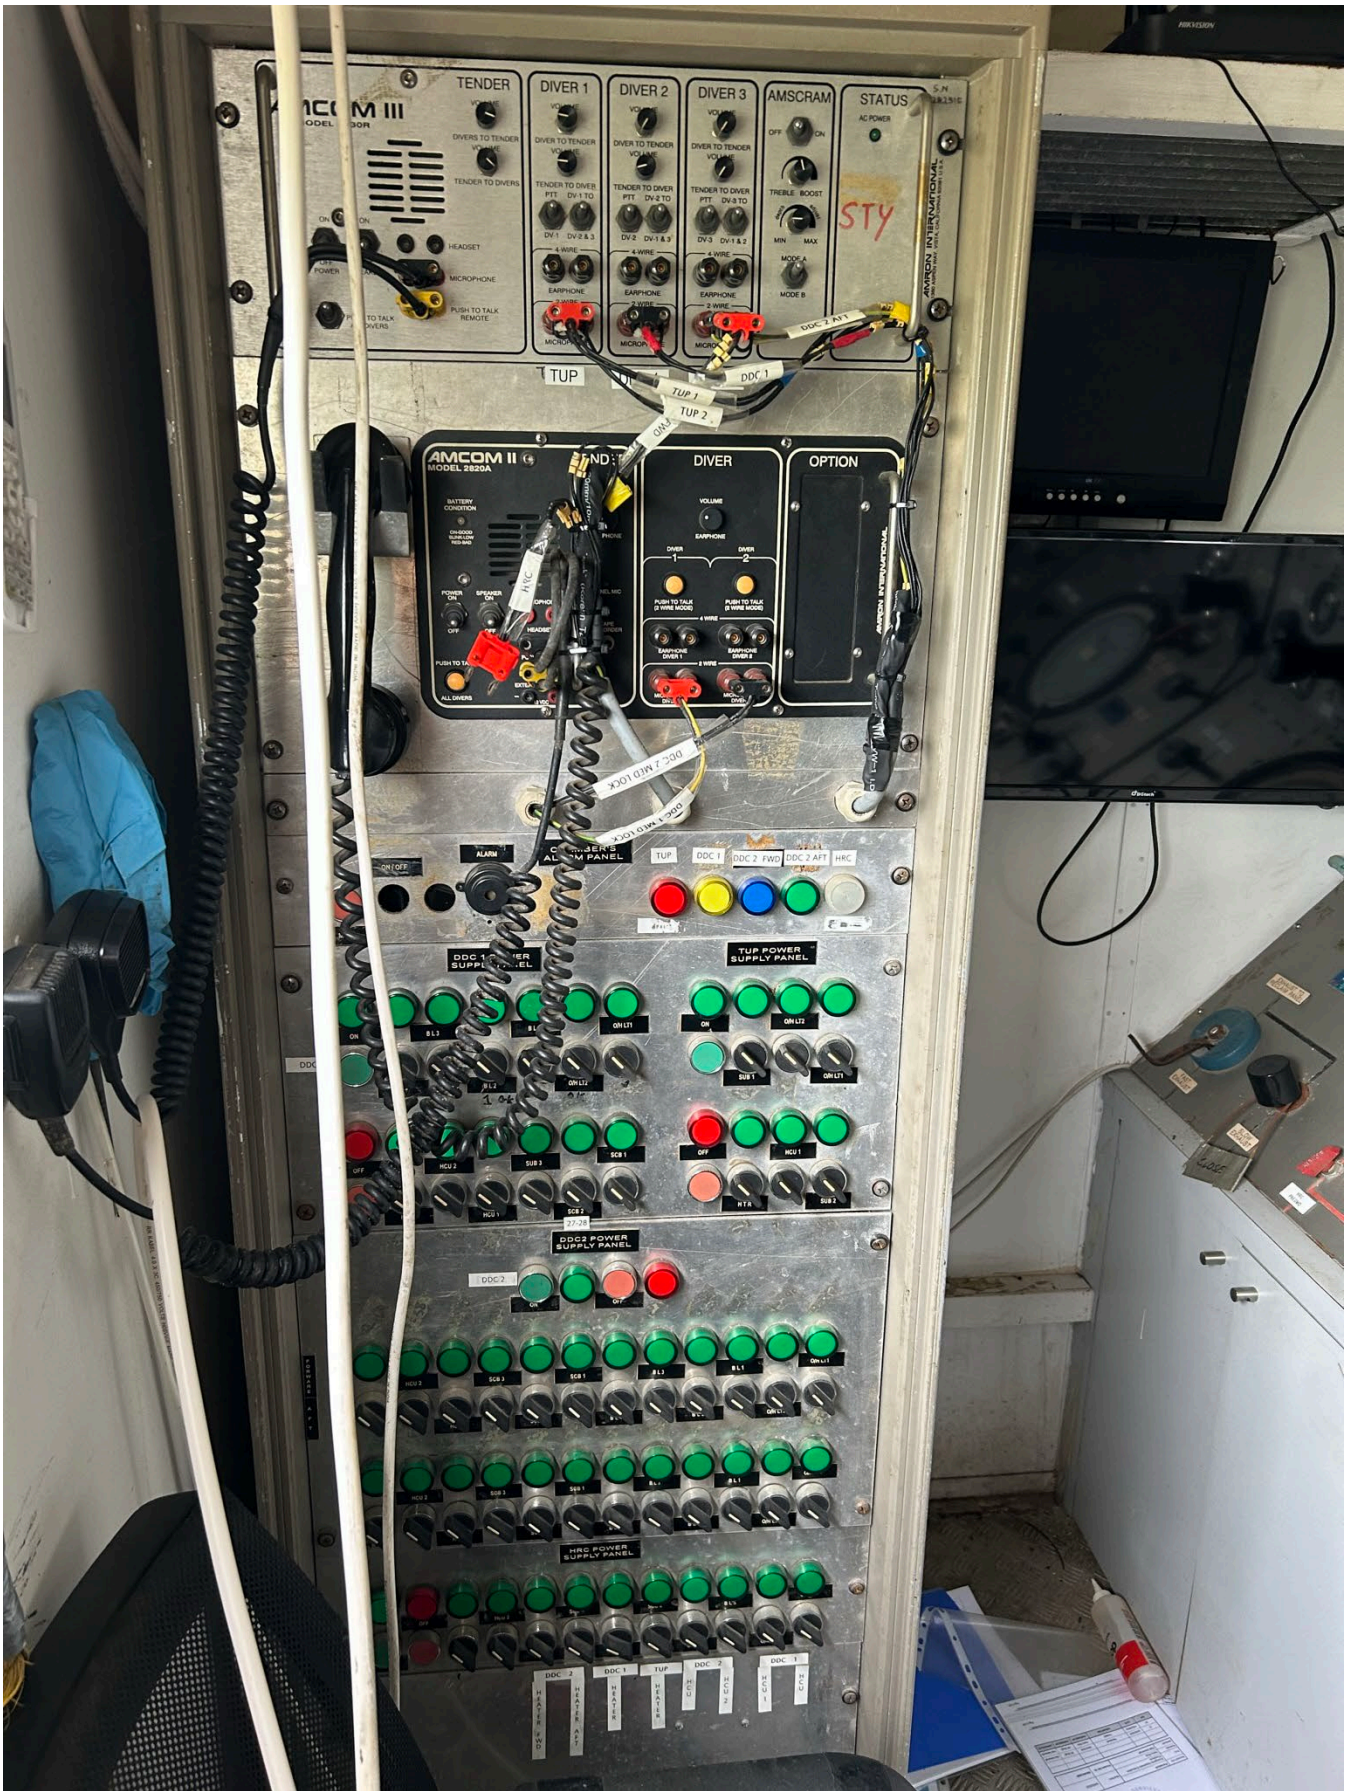
Saturation Control Unit

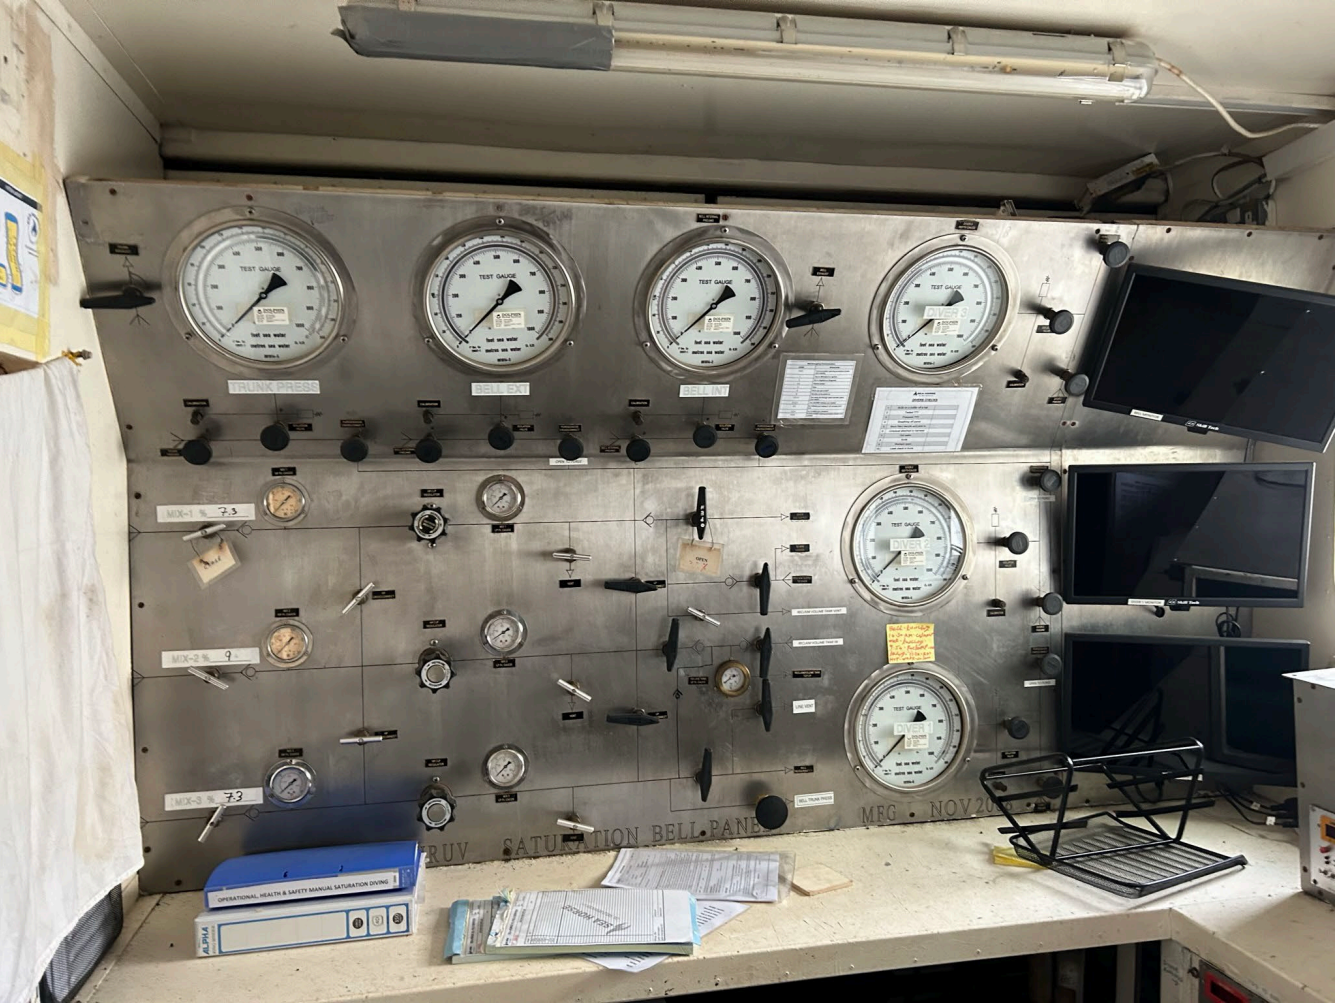
Saturation Dive Control Panel

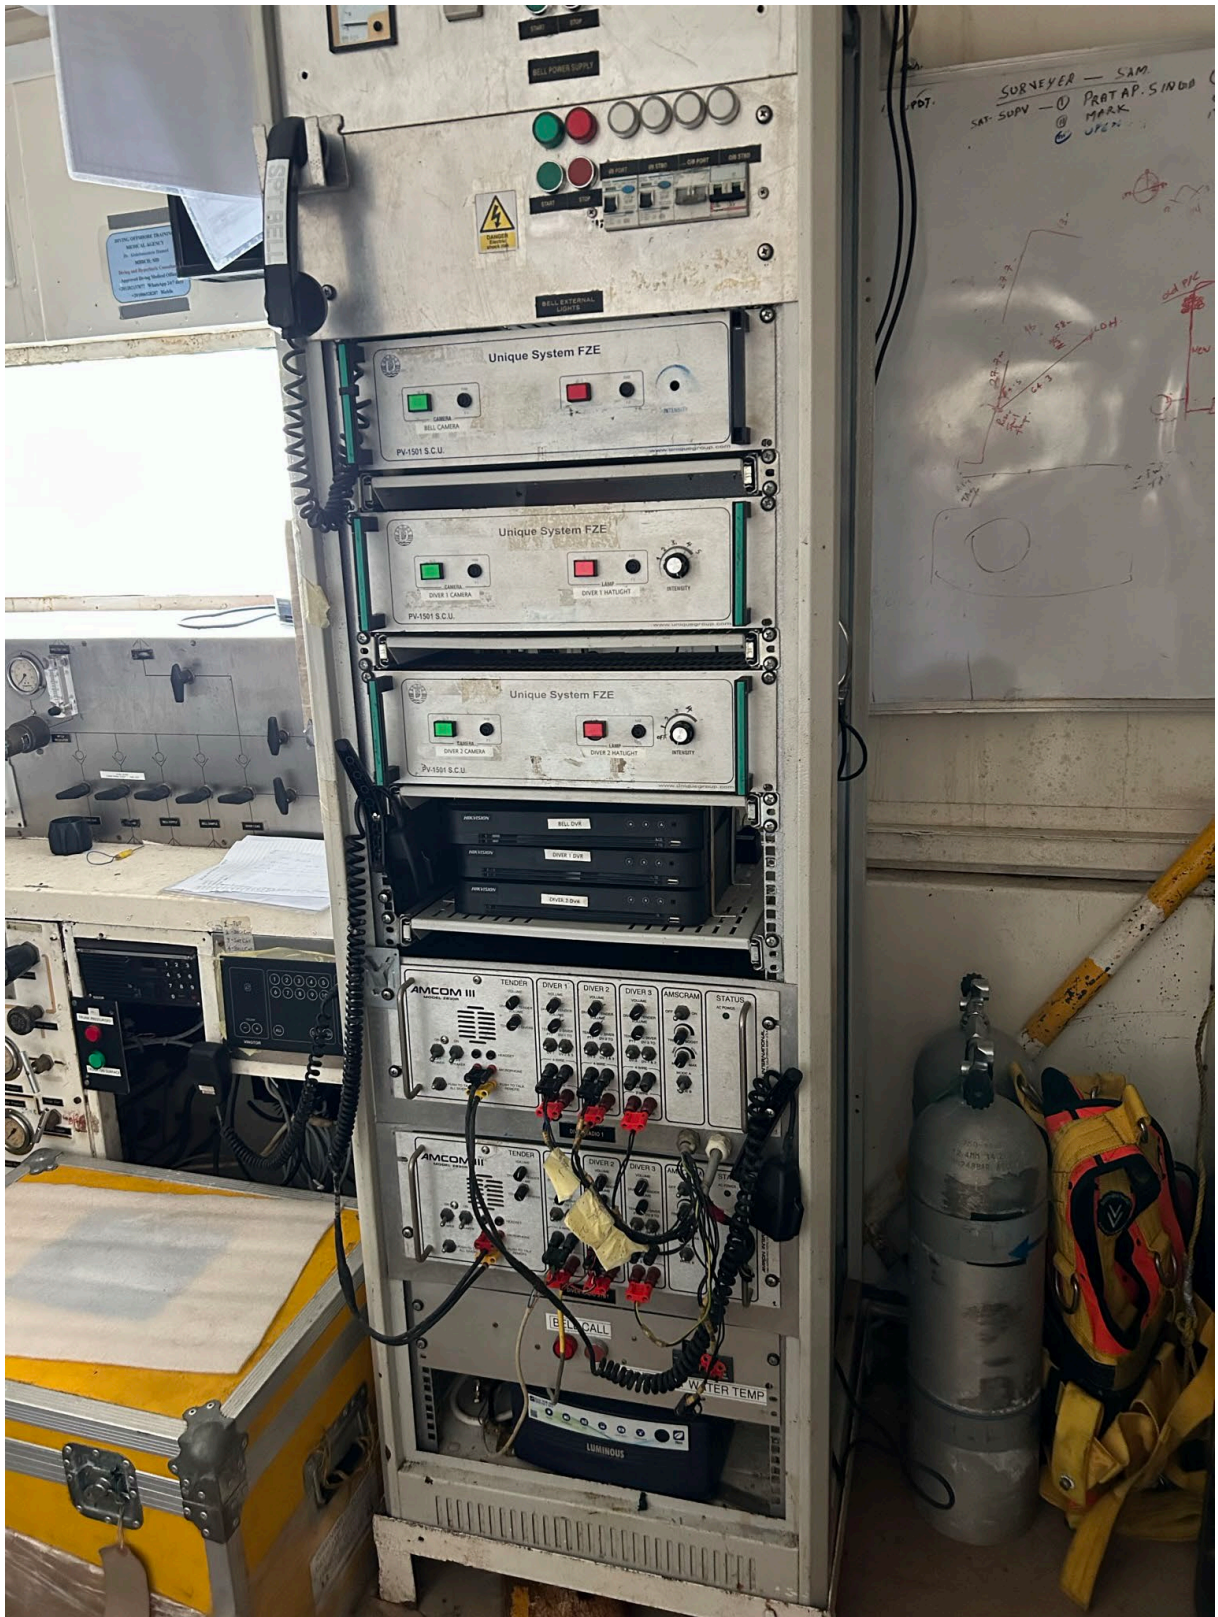
Saturation Dive Control Comms and Recording Uni

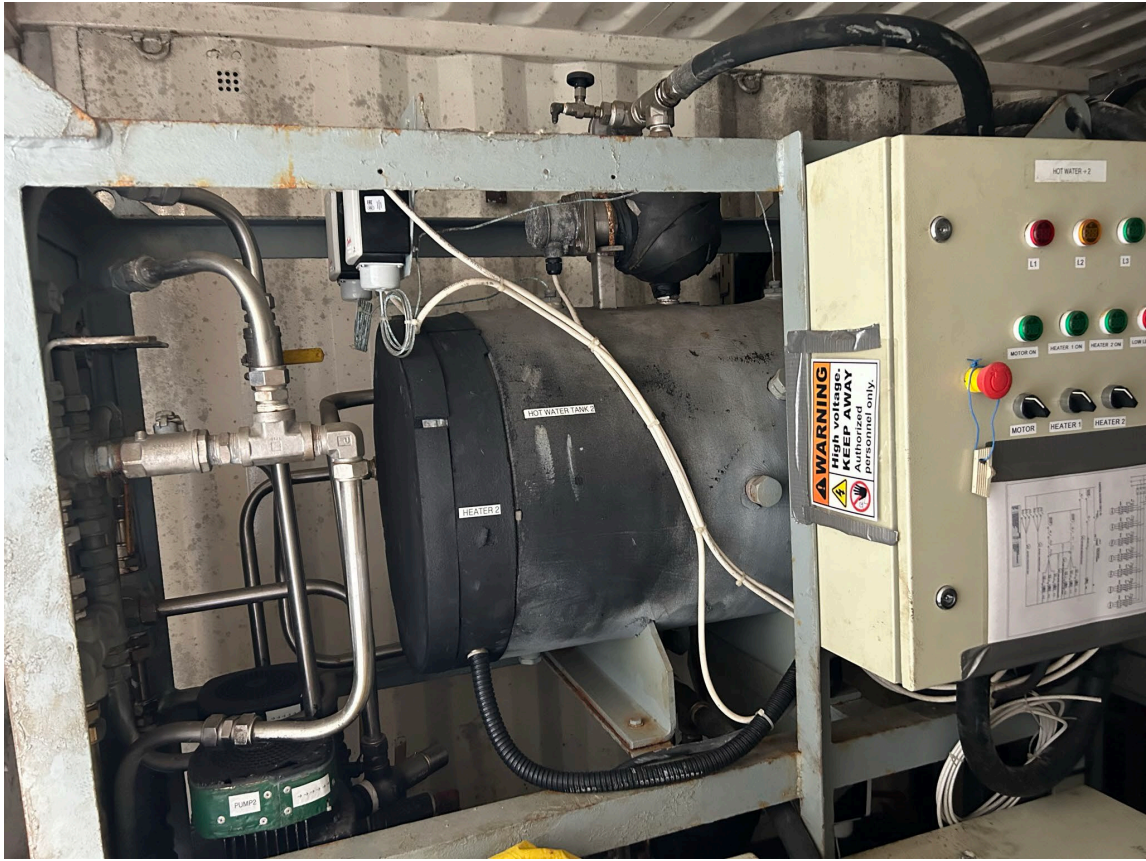
Hot Water Unit

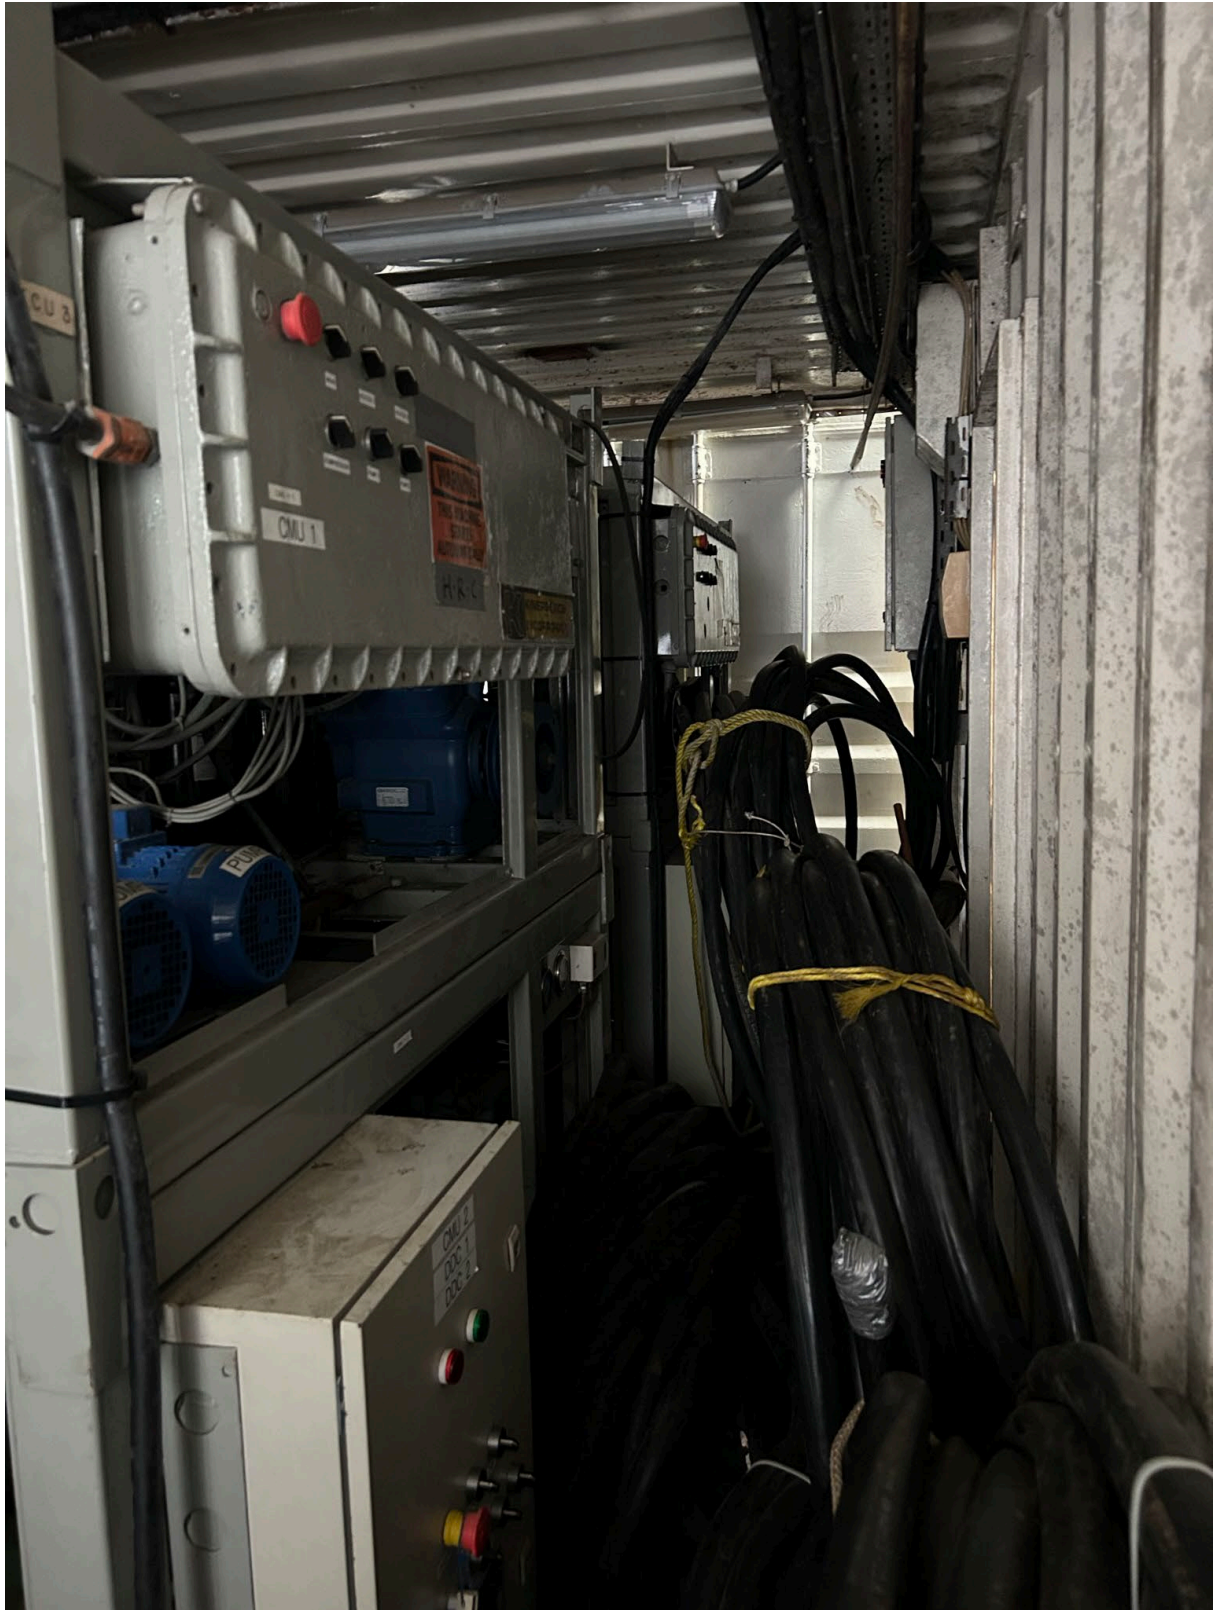
CMU's

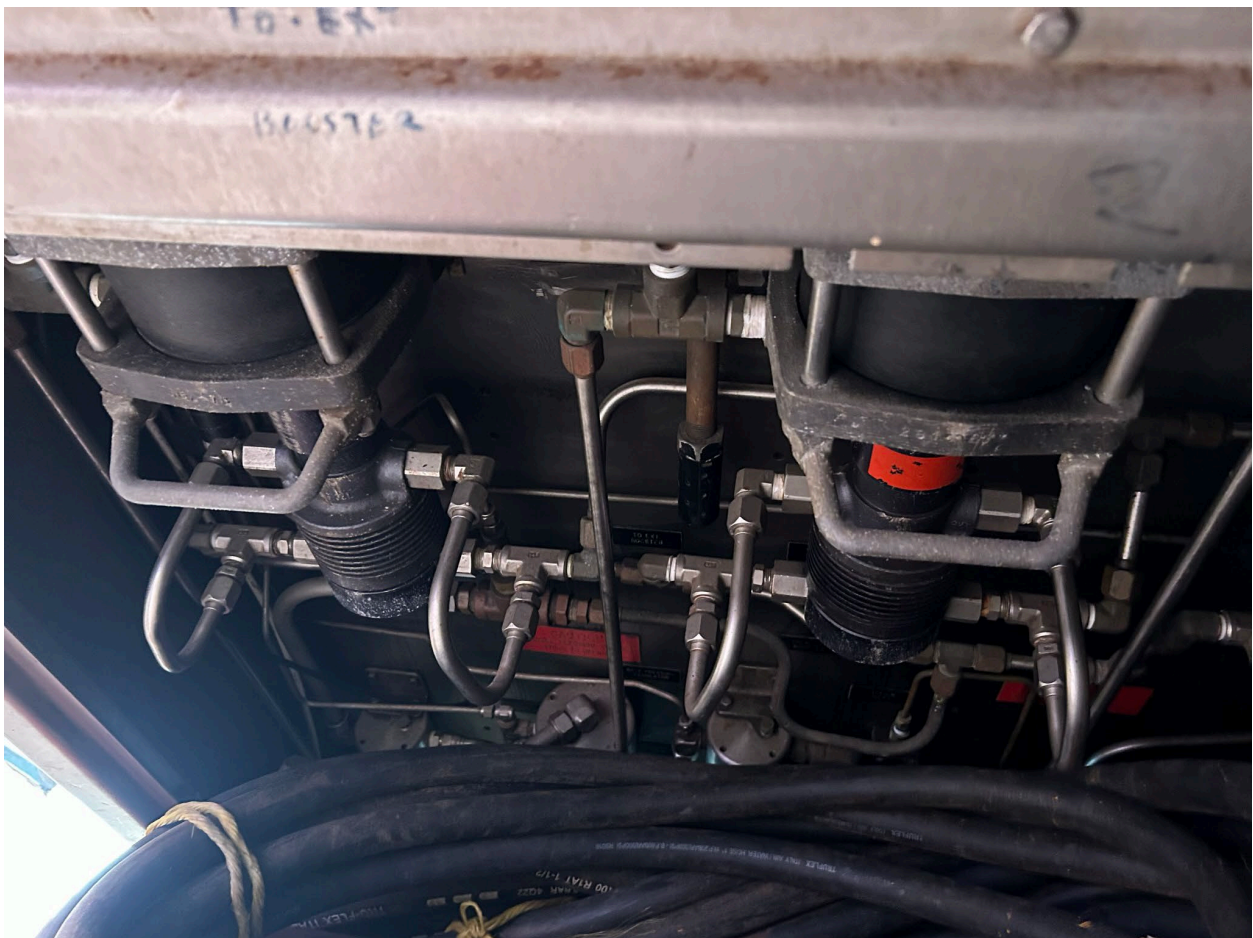
Gas Reclaim system
