1 INTRODUCTION 2024

This document describes the currently noted details and brief inventory the Nobel Ten Saturation Diving System located in Takoradi, Ghana.

2 NOBEL TEN SATURATION DIVING SYSTEM

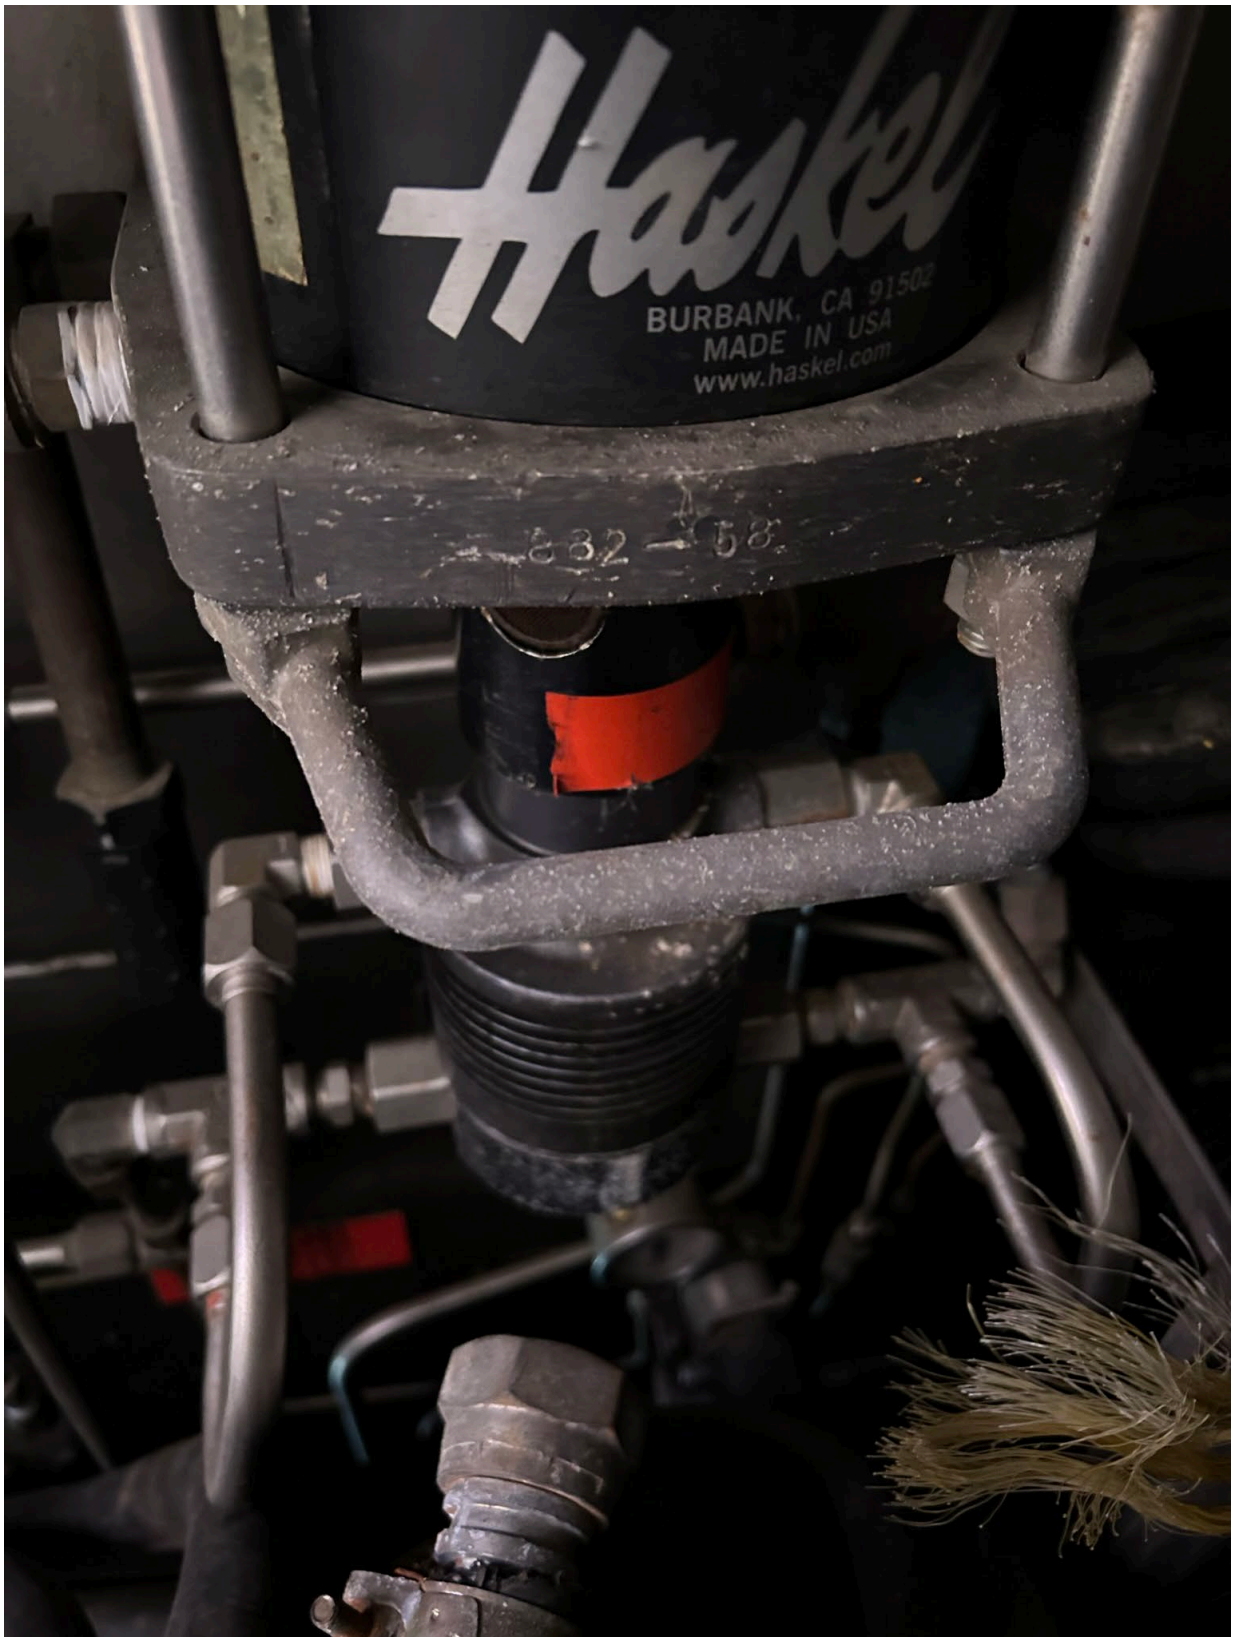
Haskel Pump on Gas Reclaim system

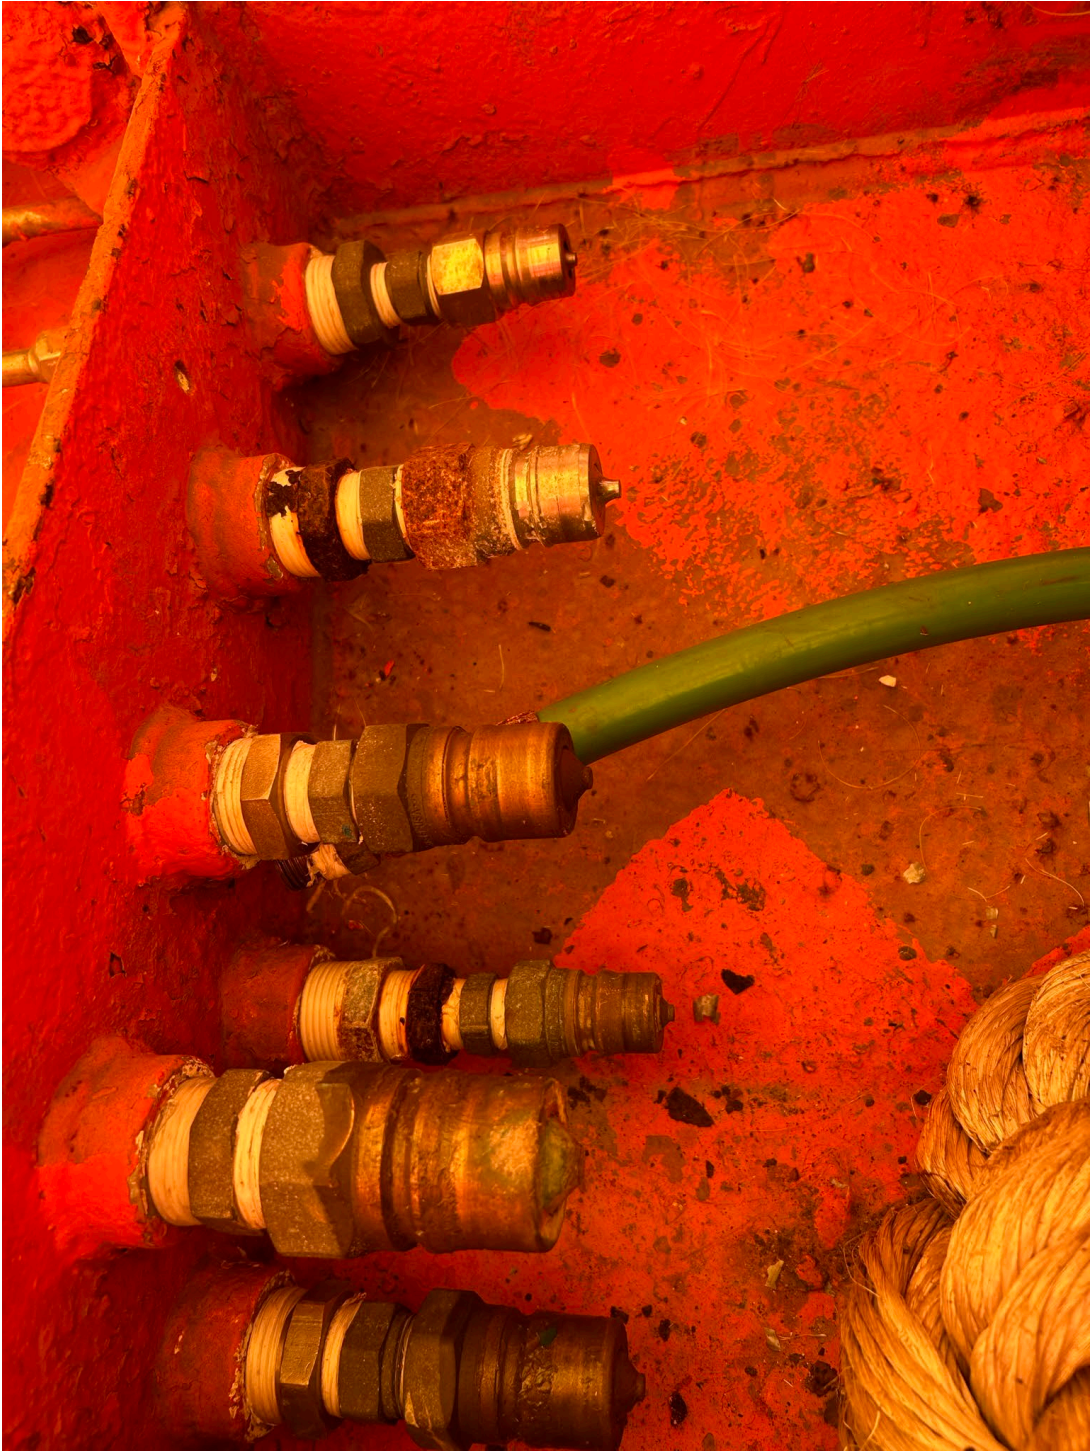
HRC Fittings/Connections

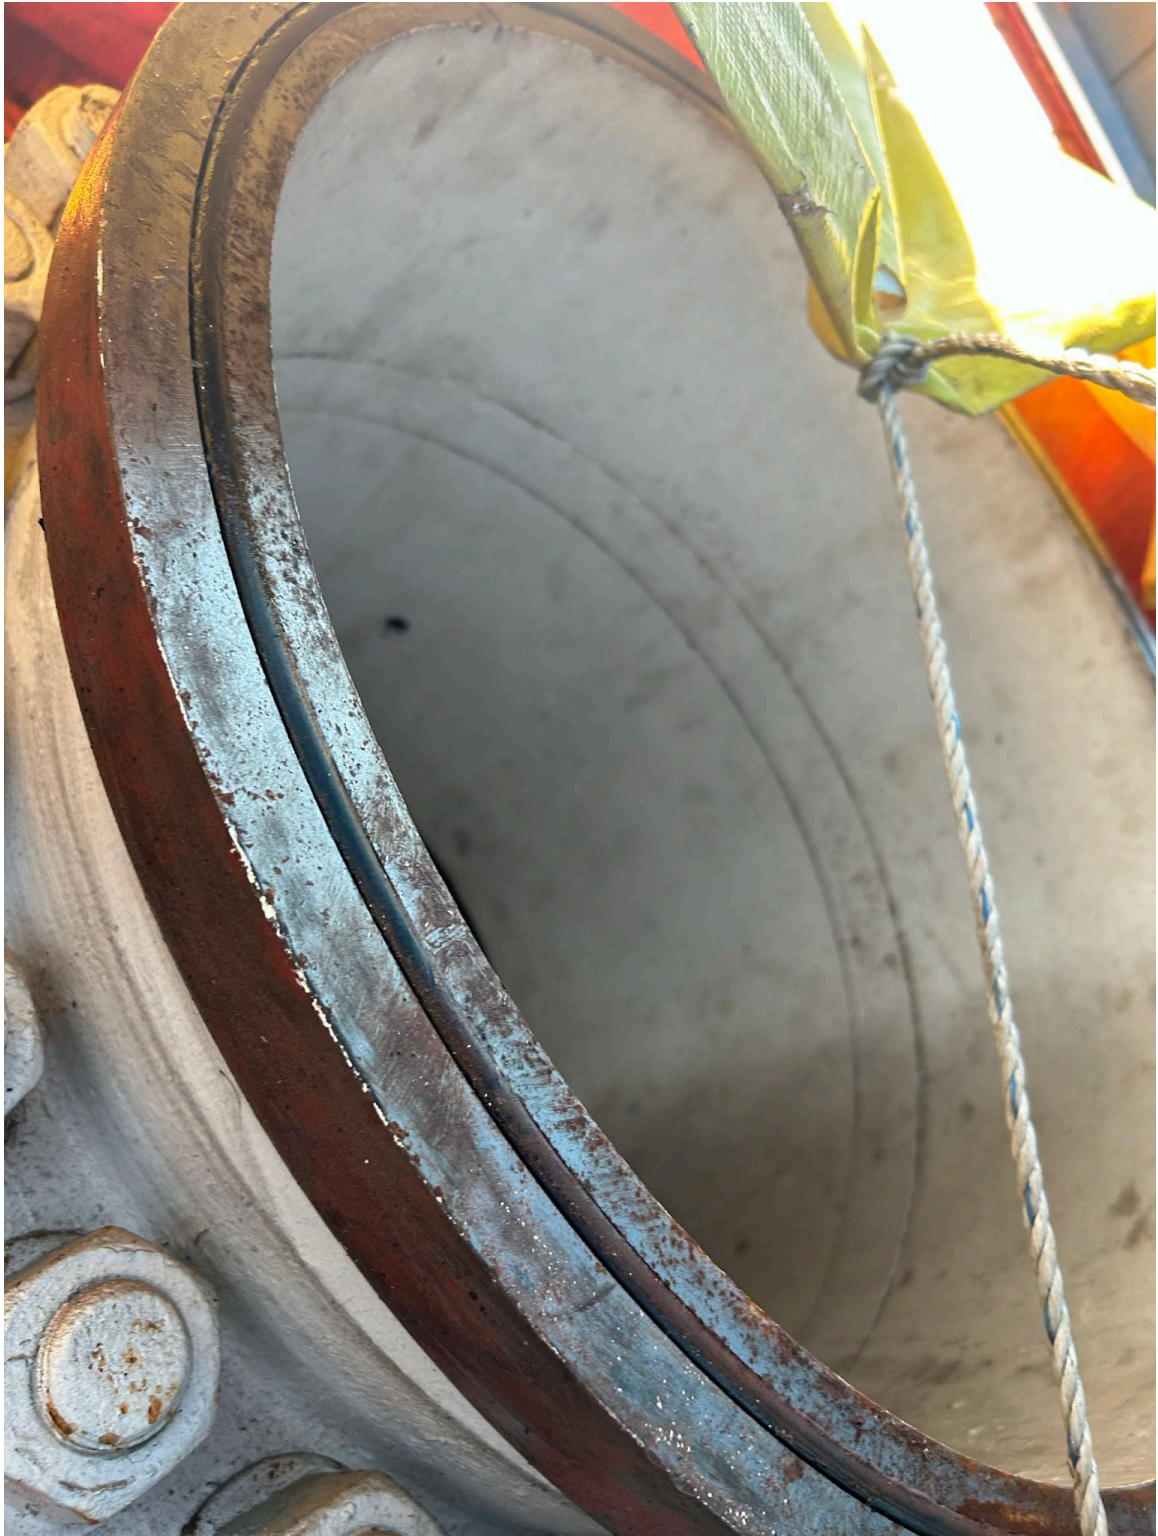
HRC Trunking and sealing face

There will be a requirement to conduct a seal/leak test which can be facilitated by using an air compressor and qualified technicians.

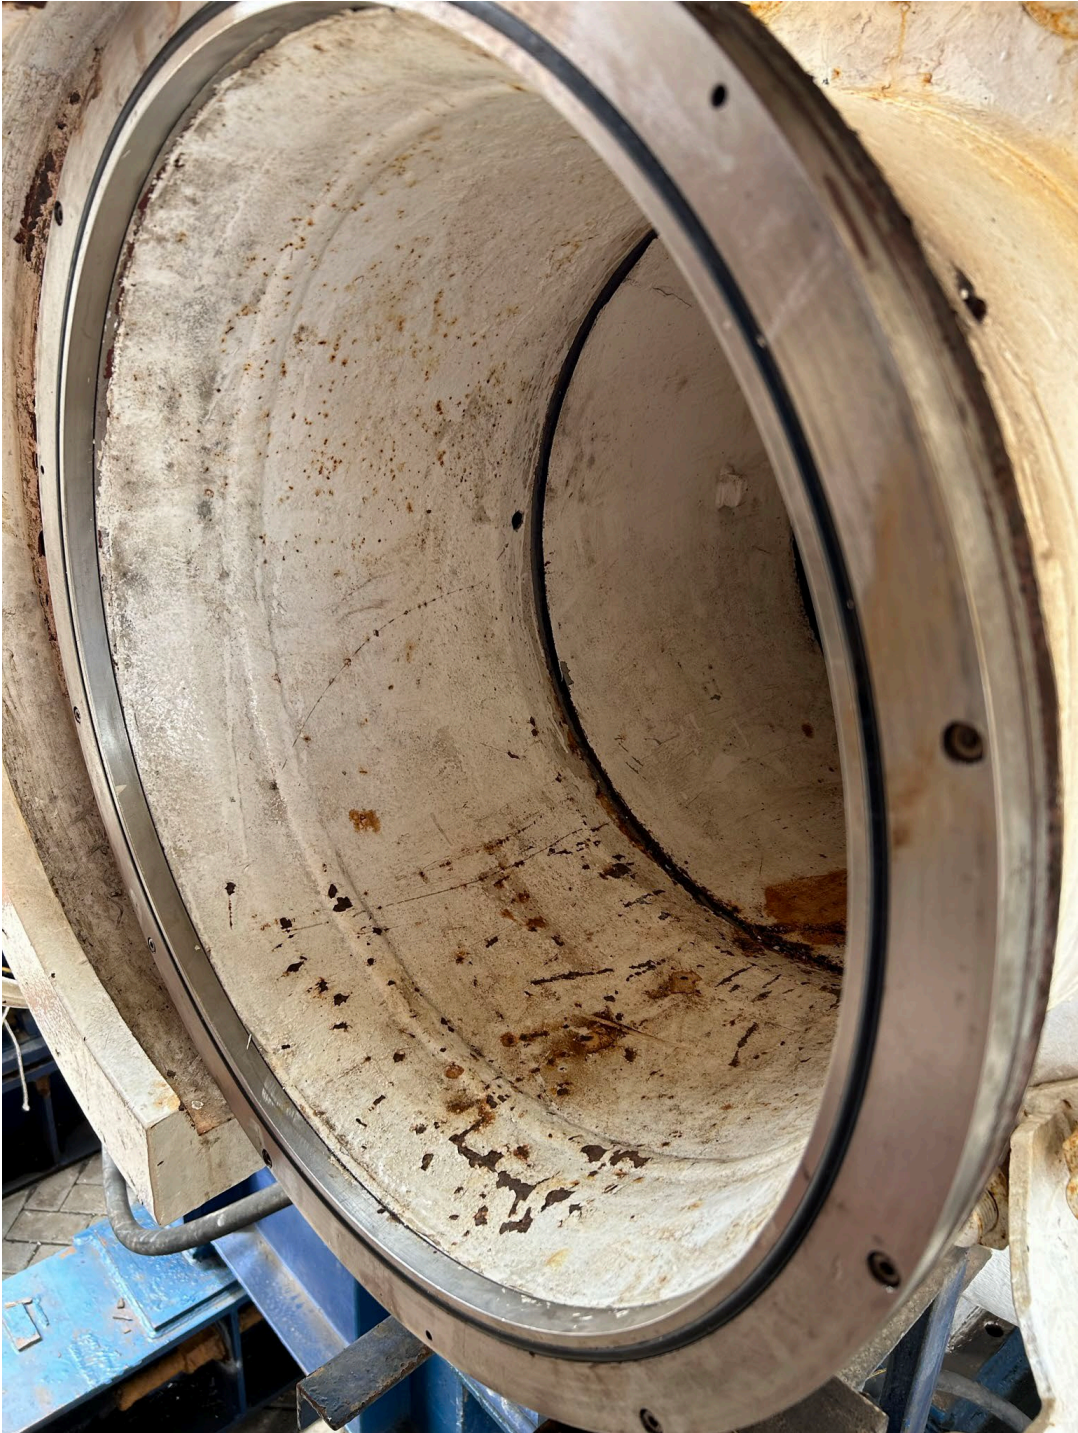
TUP Trunking & Sealing Face to Bell

There will be a requirement to conduct a seal/leak test which can be facilitated by using an air compressor and qualified technicians.

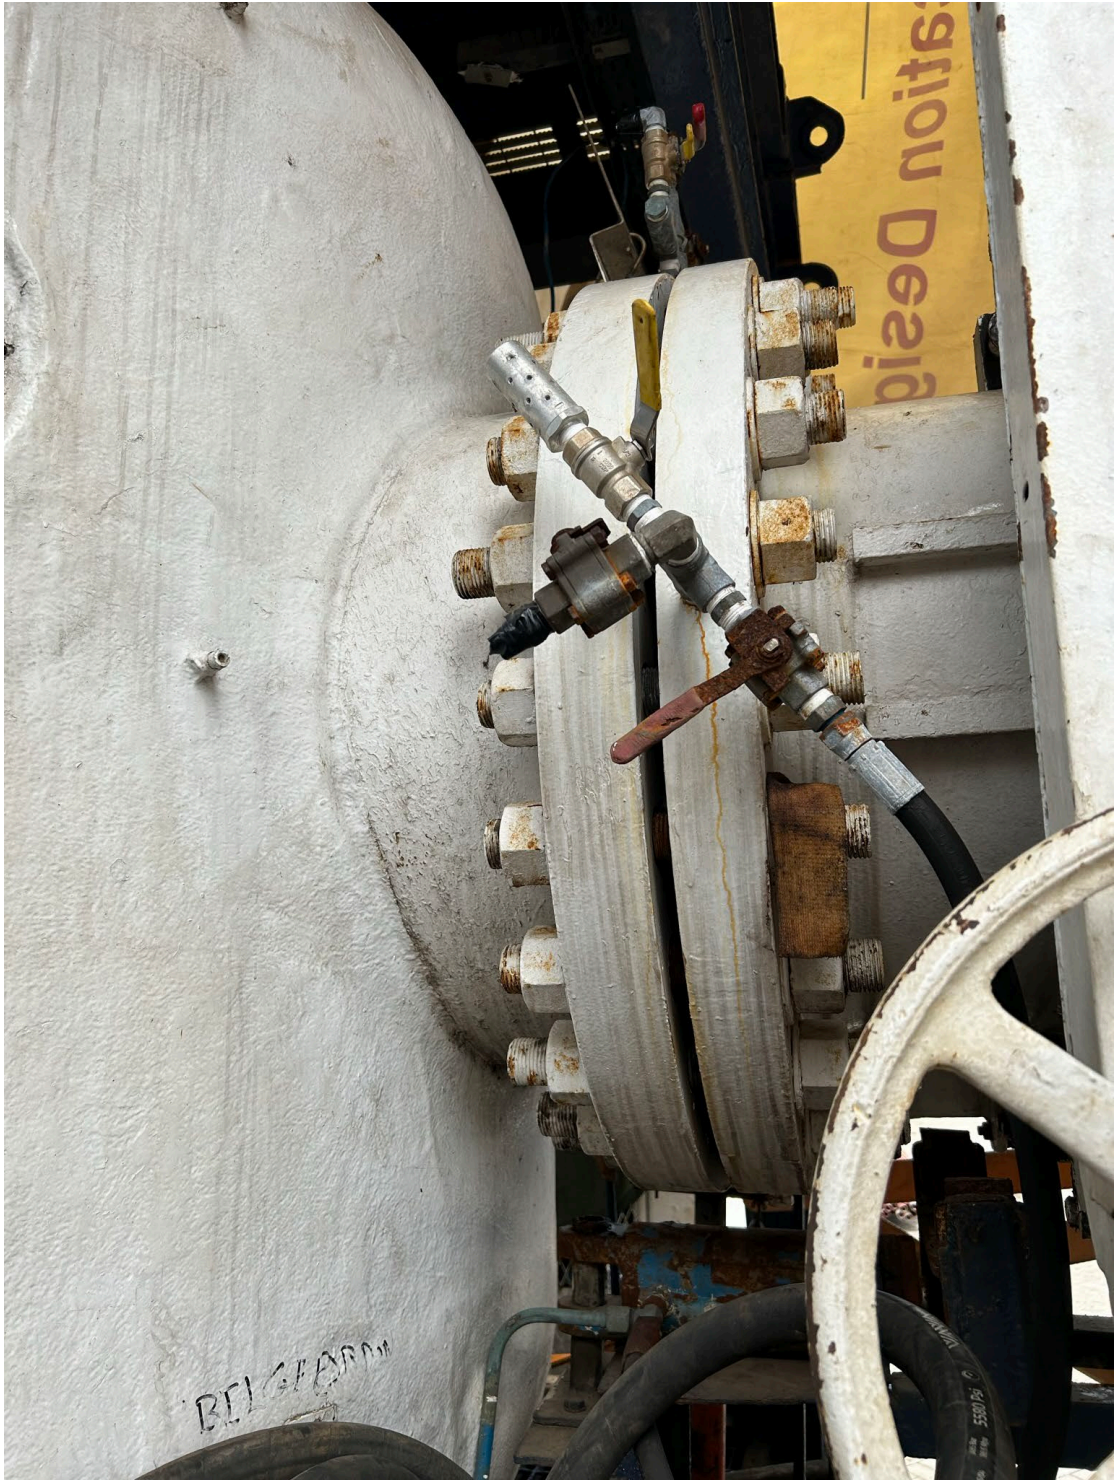
TUP to DDC I Trunking

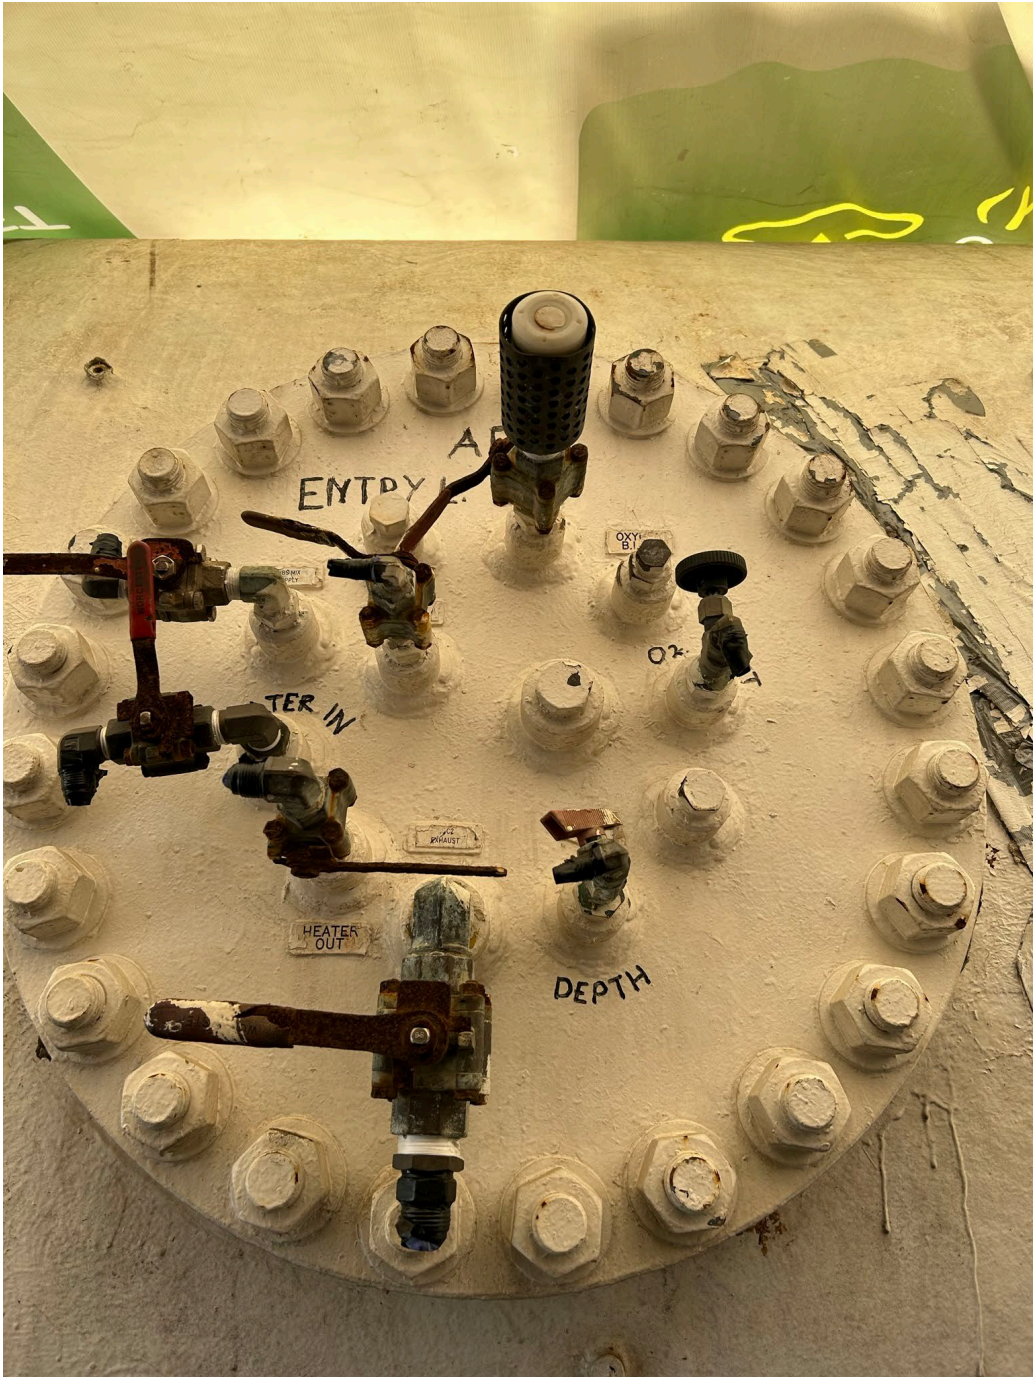
DDC 1 Penetrator Flange

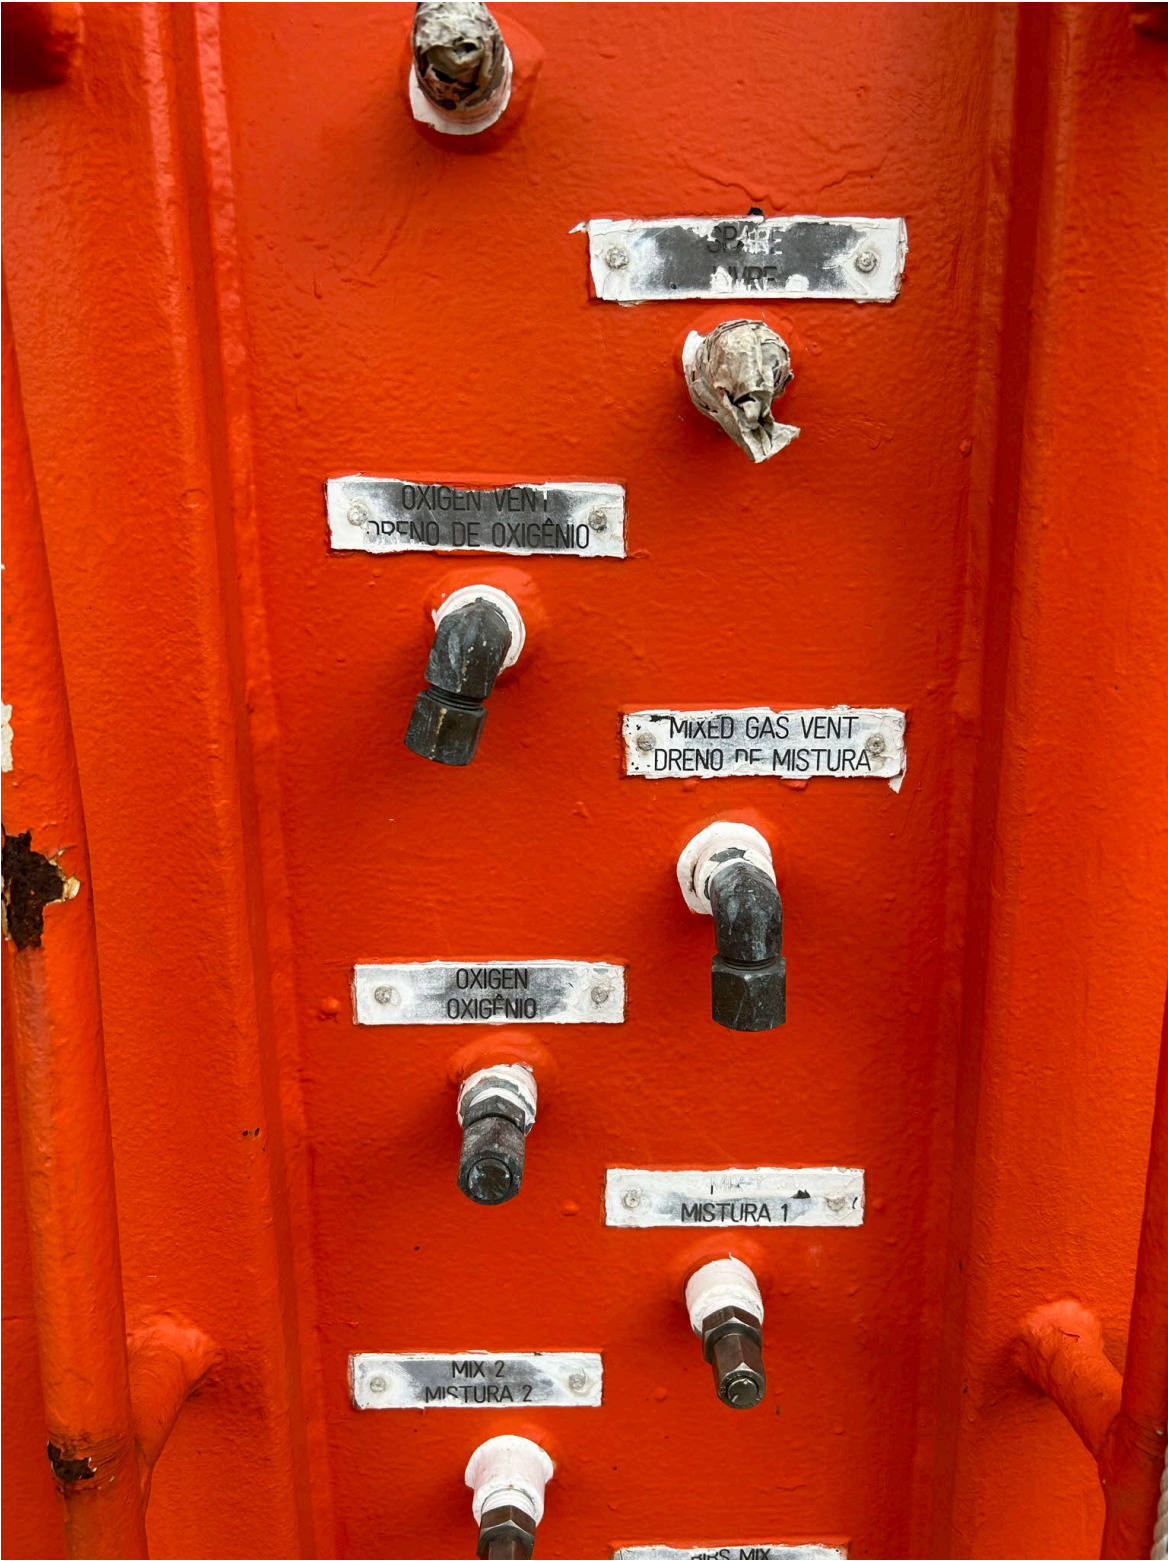
External Penetrator Panel

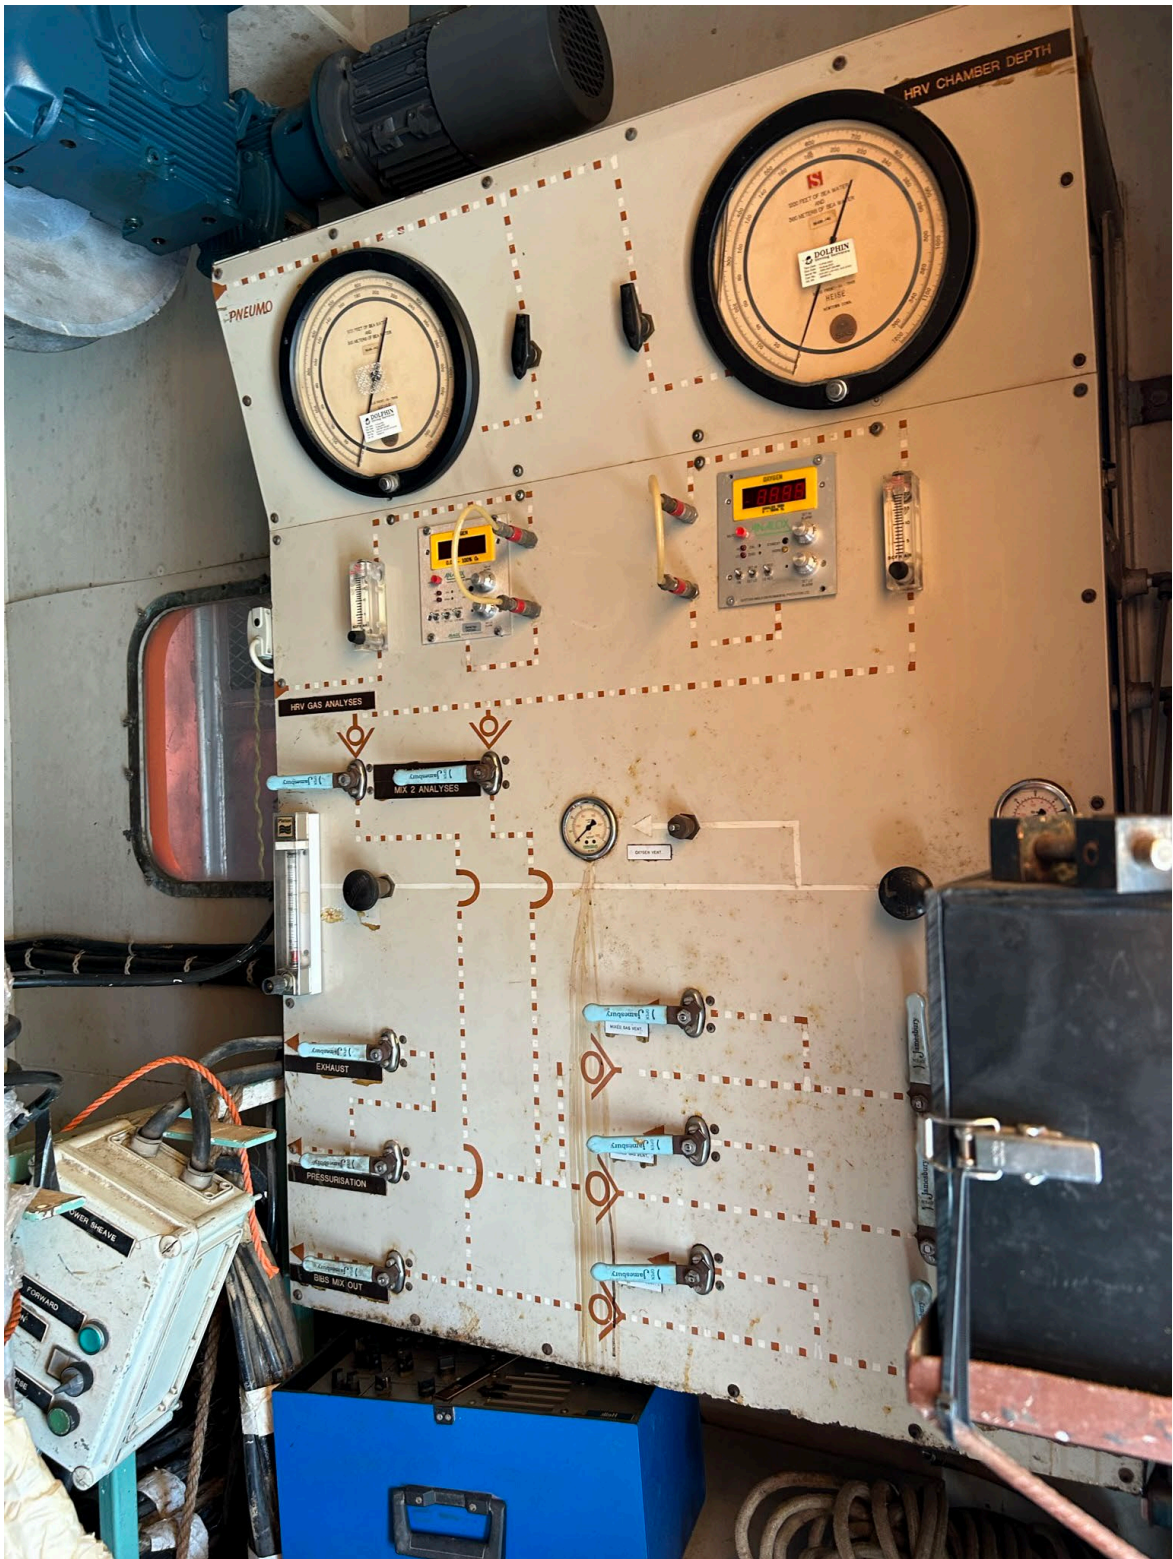
Panel for Fly Away Pack

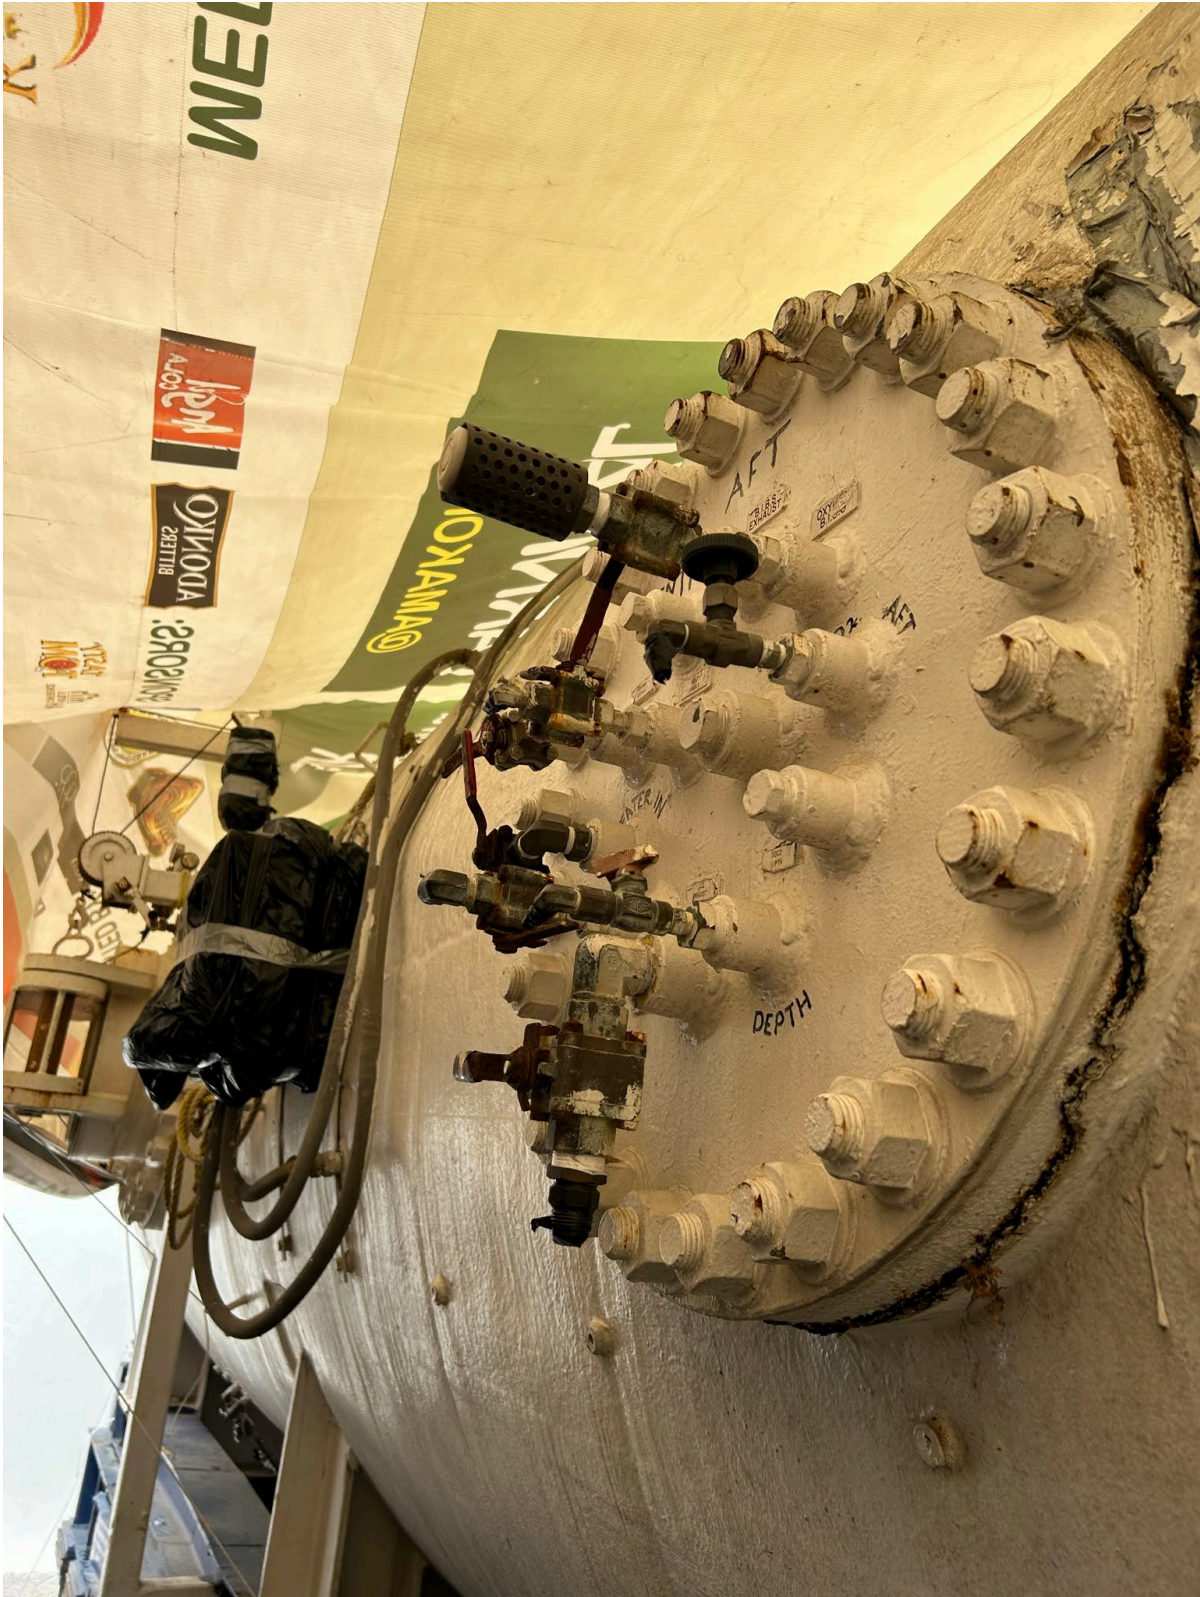
Description:	VISIBLE CONDITION:	NOTES:
Overall Exterior	OK	Needs minor fiberglass/insulation repairs, badging/labelling, blasting & Painting
Viewports	Good	Certifications need to be checked
Valves, fittings & Pipework	OK	Some of the valves and fittings need to be replaced
Penetrator Panel	Good	All look ok
Med Lock	Good	Needs to be seal tested
Trunking	Good	Needs to be seal tested
Internal areas	TBC	No Access

The overall condition of the DDC 2 appears to be in OK visible condition. All items listed above are very minor and can be rectified quickly and efficiently.

There will be a requirement to conduct a seal/leak test which can be facilitated by using an air compressor and qualified technicians.

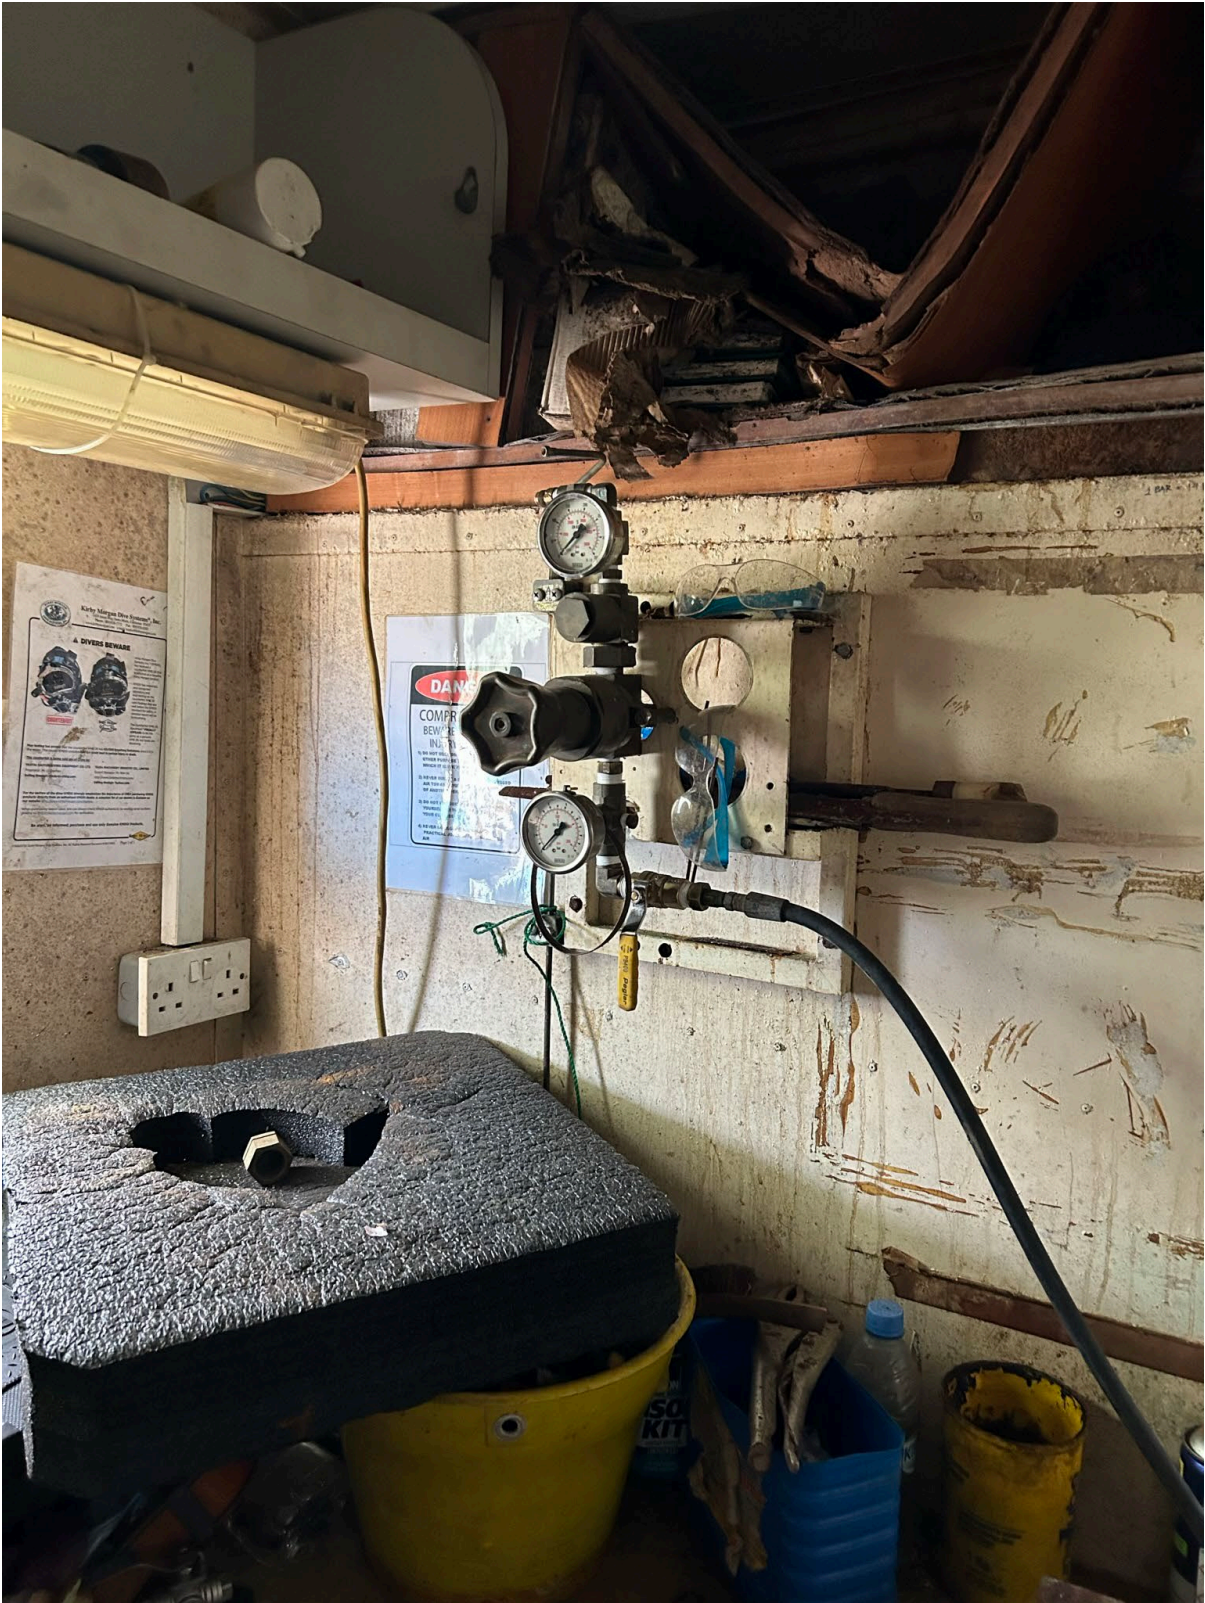
Compressed Air Panel

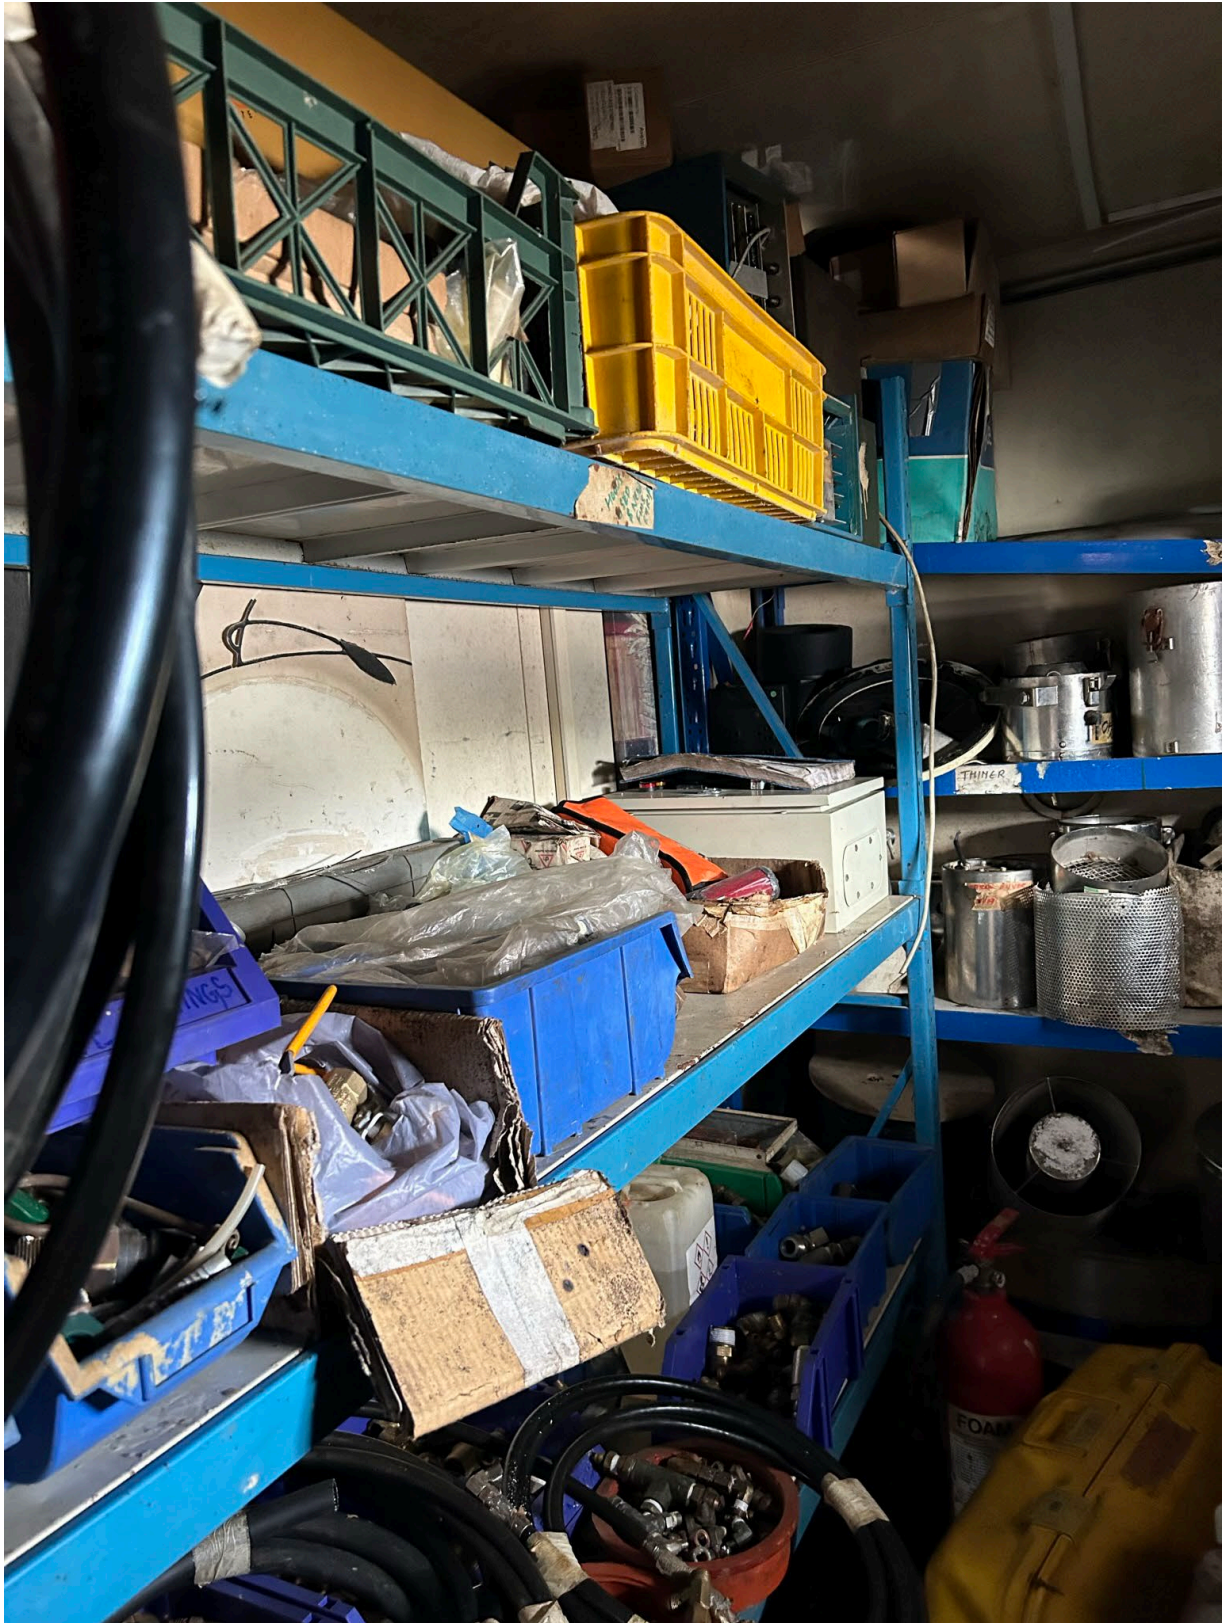
Description:	VISIBLE CONDITION:	NOTES:
Overall Exterior	OK	Needs minor steel repairs, blasting & Painting
AC Unit	OK	Needs Servicing
Hydraulic Hand Pump	Good	All OK
Hand Tools and various Tooling	Poor	Needs to be cleaned up, all tooling fully inventoried, proper tool boxes, shelving added
Compressed Air Manifold	OK	Needs to be tested
Hydraulic Control Unit for Bell	OK	Needs to be tested
DIVEX BIBS	OK	Need to be tested
Fittings, hoses, valves, connectors	OK	All needs to be tested
Lighting	OK	Needs to be tested

Shelving and Various Spares
