Pipe-Layer Barge

PRE-PURCHASE REPORT

INSPECTION DATE: 21 July 2024

REPORT DATE: 25 July 2024

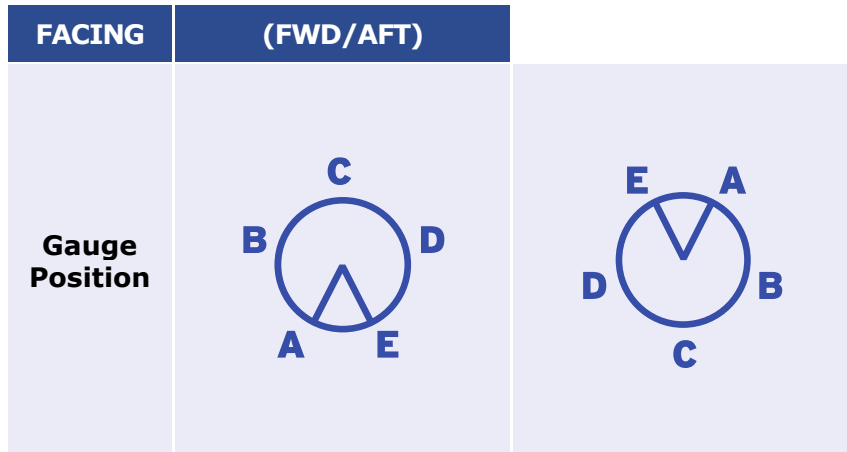
10.6 CRANKSHAFT DEFLECTIONS

1/100mm		
Date	-	
Draught	Forward	-
Draught	Aft	-

UNIT No:	1	2	3	4	5	6	7	8	9
A	-	-	-	-	-	-	-	-	-
B	-	-	-	-	-	-	-	-	-
C	-	-	-	-	-	-	-	-	-
D	-	-	-	-	-	-	-	-	-
E	-	-	-	-	-	-	-	-	-
